NILU : OR 39/2000
REFERENCE : O-8208
DATE : SEPTEMBER 2000
ISBN : 82-425-1202-7

**International Co-operative
Programme on Effects on Materials,
including Historic and Cultural
Monuments**

**Evaluation of decay of painted systems for steel
after 1 and 2 years of exposure (1997-1999)**

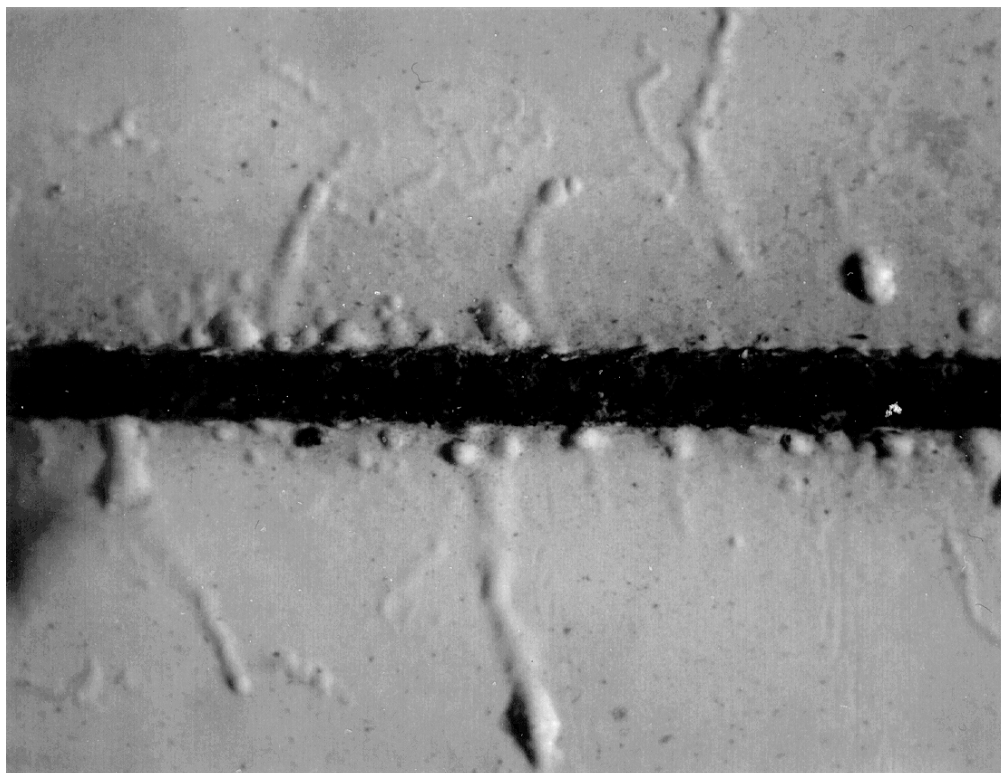
While flaking and blistering were the dominating form for damage in the first phase of the programme, filiform attack occurs more frequently in the second phase. Figure 1 show a typical example of this type of attack taken from the two years of exposure at Lincoln Cathedral. Table 2 gives the results of filiform corrosion for the test sites and the evaluation technique used is illustrated in Figure 2.

Figure 1: Filiform attack from the cut on alkyd painted panels at site Lincoln Cathedral.

Filiform attack will reach further out from the cut than the blisters and is observed for 13 sites after two years for the second phase. Among the sites that are included in both periods, 3 had filiform attack in the first phase 1987-88, while 6 sites had that attack in the second phase. For the 8 new sites in added to the programme 7 of the sites had filiform corrosion both after one and two years. Filiform corrosion is complicated to evaluate since it is large deviation been the parallels. Further the distinctness of the filiform corrosion differed from one panel to the next. Often filiform corrosion may occur only on one of the three panels. This is marked in Table 2.

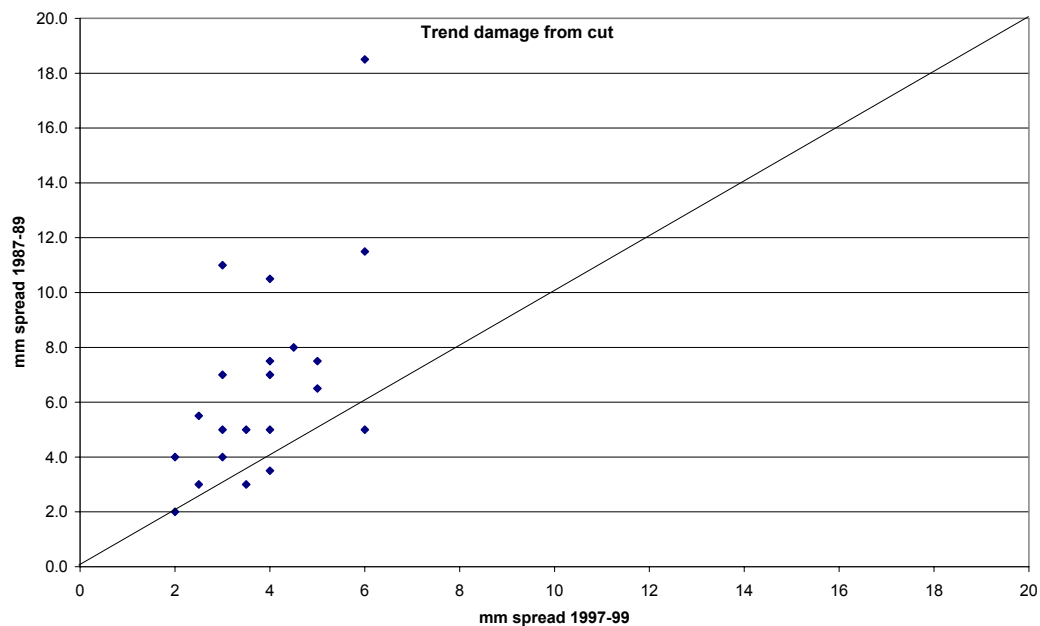
Figure 3: The spread in damage from cut after two years of exposure for the period 1987-89 against 1997-99

From the data in Table 3 and Figure 3 it is obvious that most sites have had a positive trend for the last ten years. A slight change to more corrosion is observed on the sites 27 Lincoln Cathedral, site 34 Moscow and site 36 Lisbon. Particularly the sites with high attack in the first phase have got the largest reduction.
