NILU OR : 41/92
REFERENCE: O-8208
DATE : MAY 1992
ISBN : 82-425-0379-6

UN/ECE INTERNATIONAL CO-OPERATIVE PROGRAMME ON EFFECTS ON
MATERIALS, INCLUDING HISTORIC AND CULTURAL MONUMENTS

REPORT NO. 7
RESULTS FROM EVALUATION OF DECAY OF PAINTED
SYSTEMS FOR WOOD, STEEL AND GALVANIZED
STEEL AFTER 1 AND 2 YEARS EXPOSURE

Prepared by the Sub-centre for painted materials
Norwegian Institute for Air Research

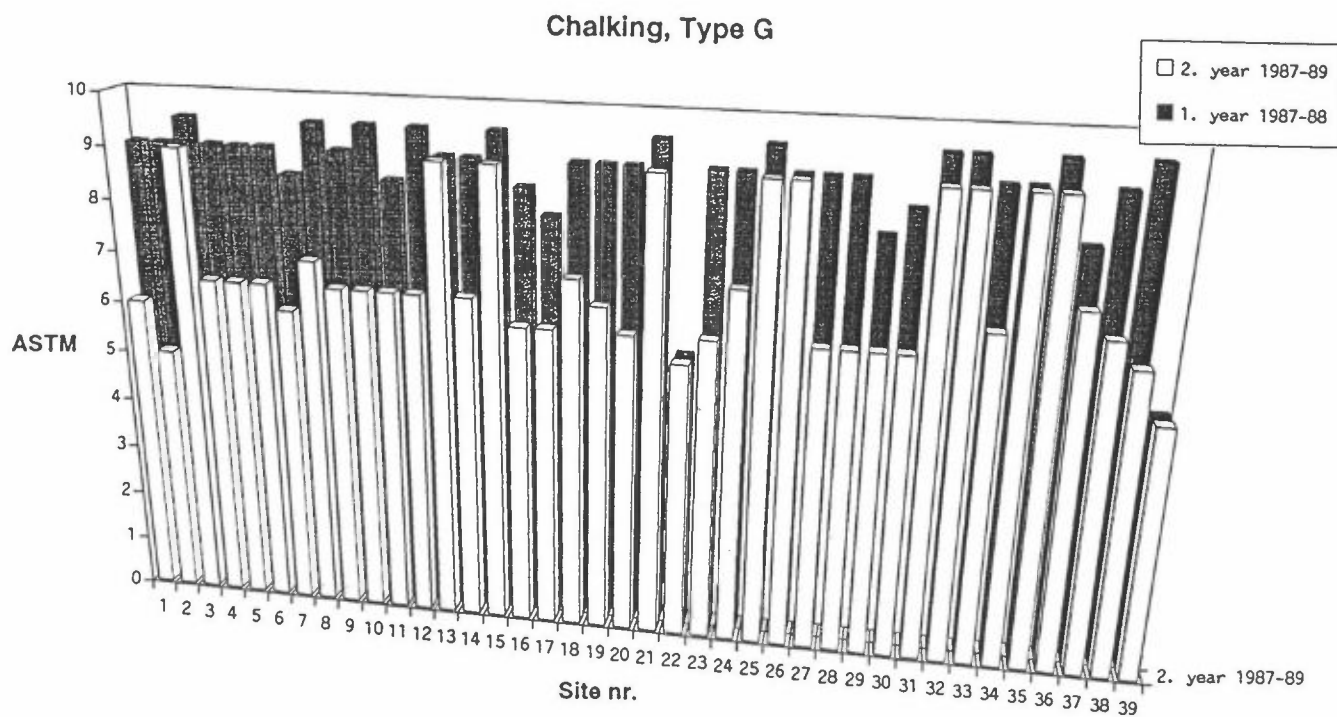
Figure 1: Chalking results for alkyd melamine paint after 1 and 2 years.

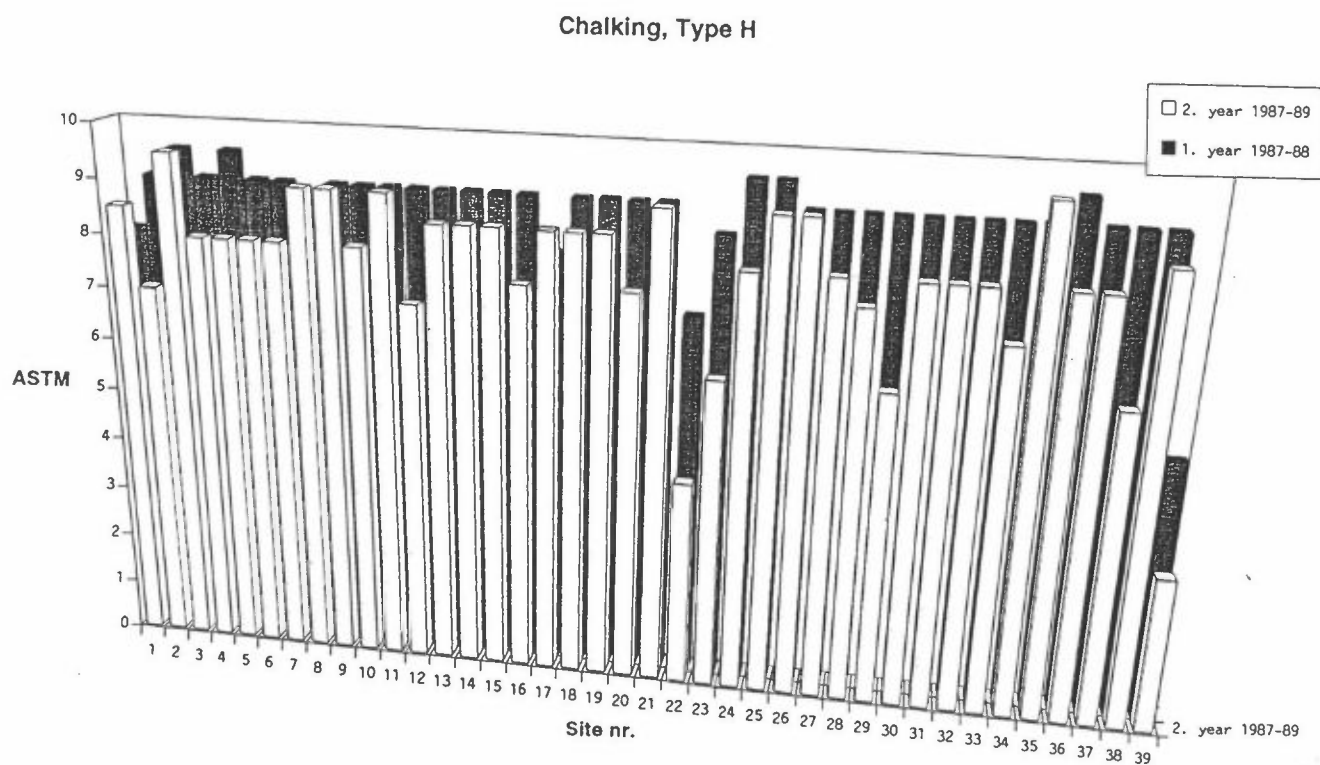
Figure 2: Chalking results for silicon alkyd paint after 1 and 2 years.

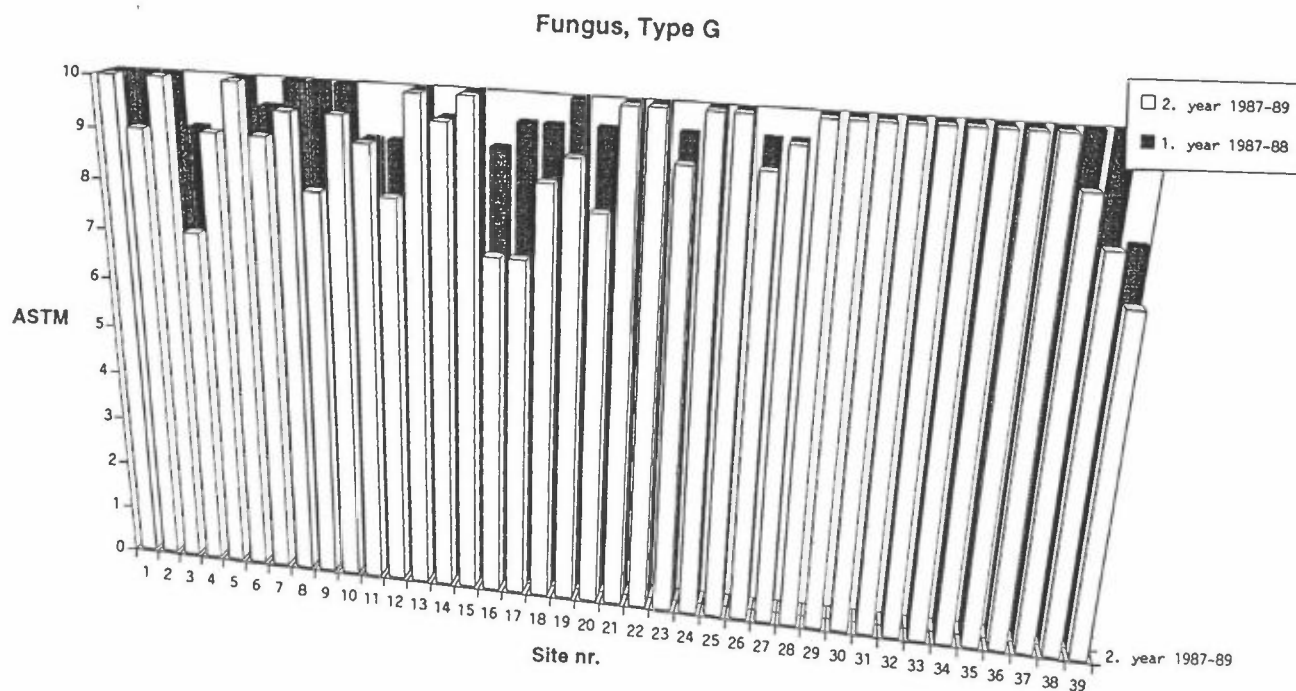
Figure 3: Fungi results for alkyd melamine paint after 1 and 2 years.

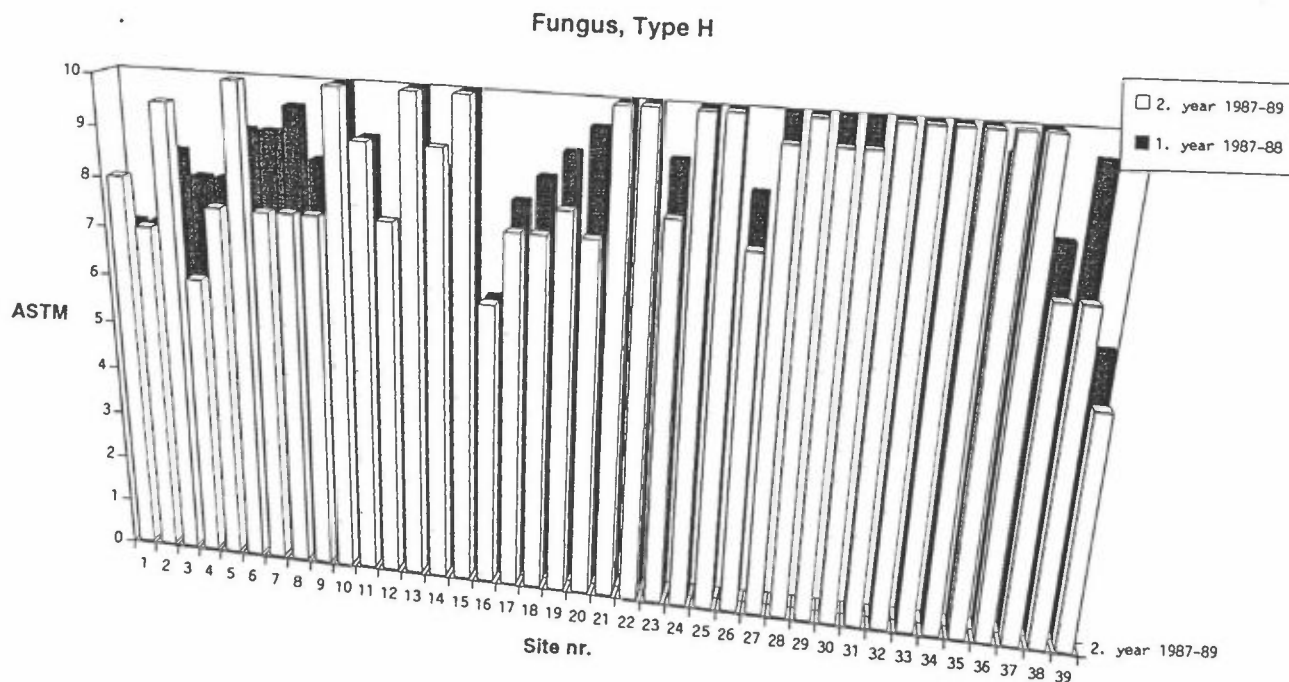
Figure 4: Fungi results for silicon alkyd paint after 1 and 2 years.

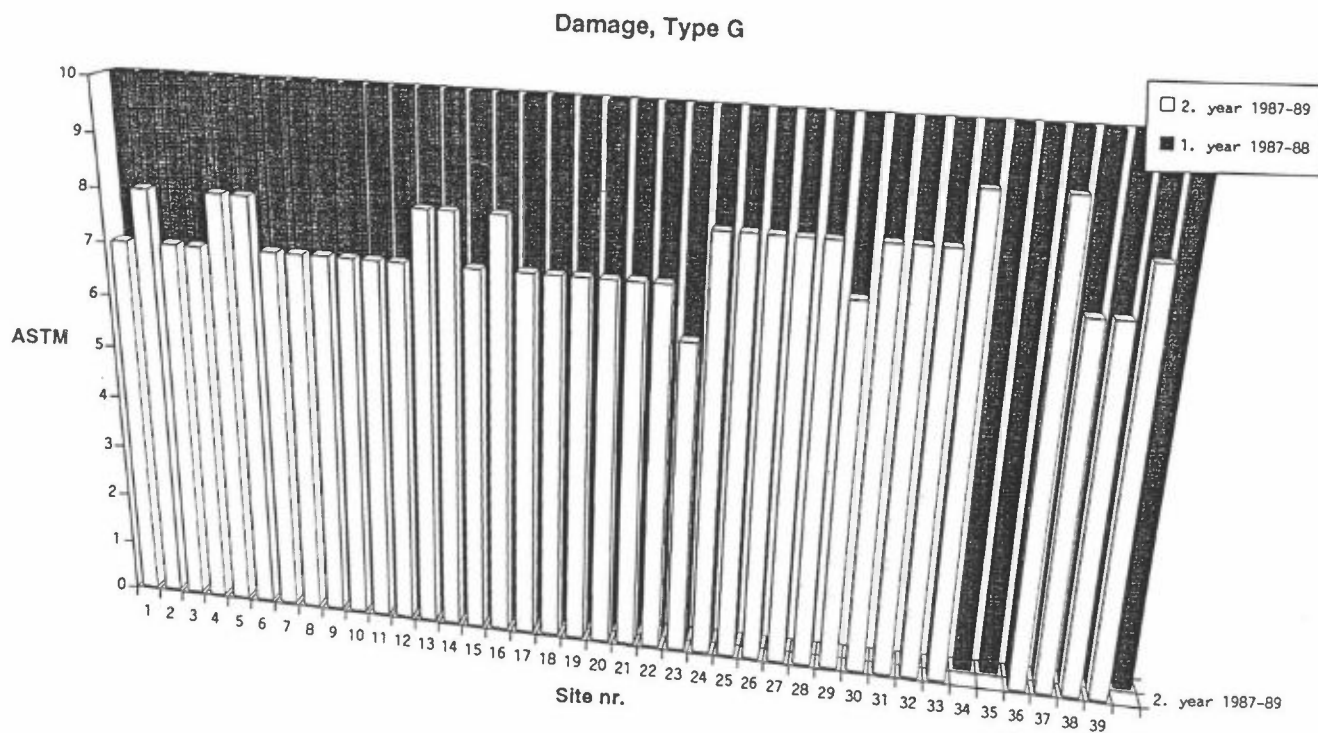
the first and second year. Particularly the steel system without zinc (H) showed attack in the cut, but all panels were effected after two years. Figure 5 and 6 show the results for the first and second year for damages along the cut.

As for the general appearance the results for the cut at the Russian and Estonian sites are not reported. The strongest effect was observed at the most polluted sites.

Figure 5: Results of the damage in and near the cut for the alkyd melamine paint after 1 and 2 years.

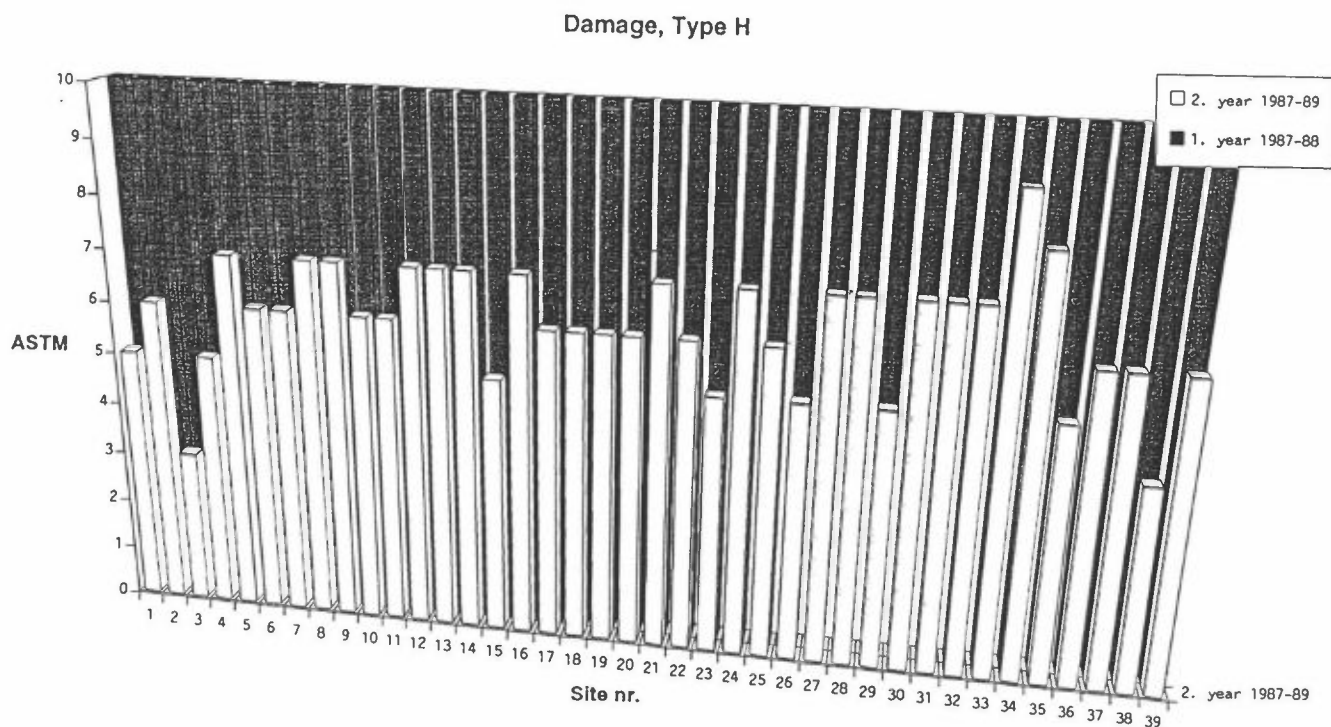
Figure 6: Results of the damage in and near the cut for silicon alkyd paint after 1 and 2 years.

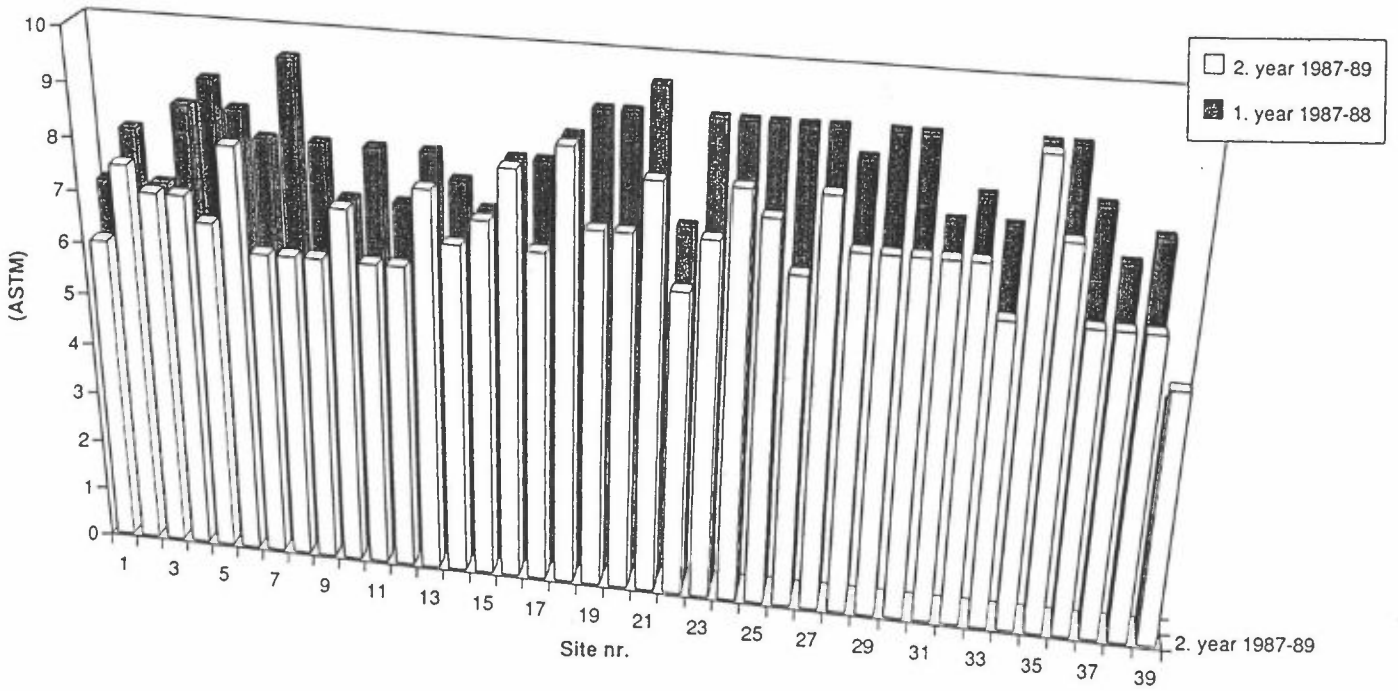
Chalking, Type I

Figure 7: Chalking results for alkyd paint after 1 and 2 years.

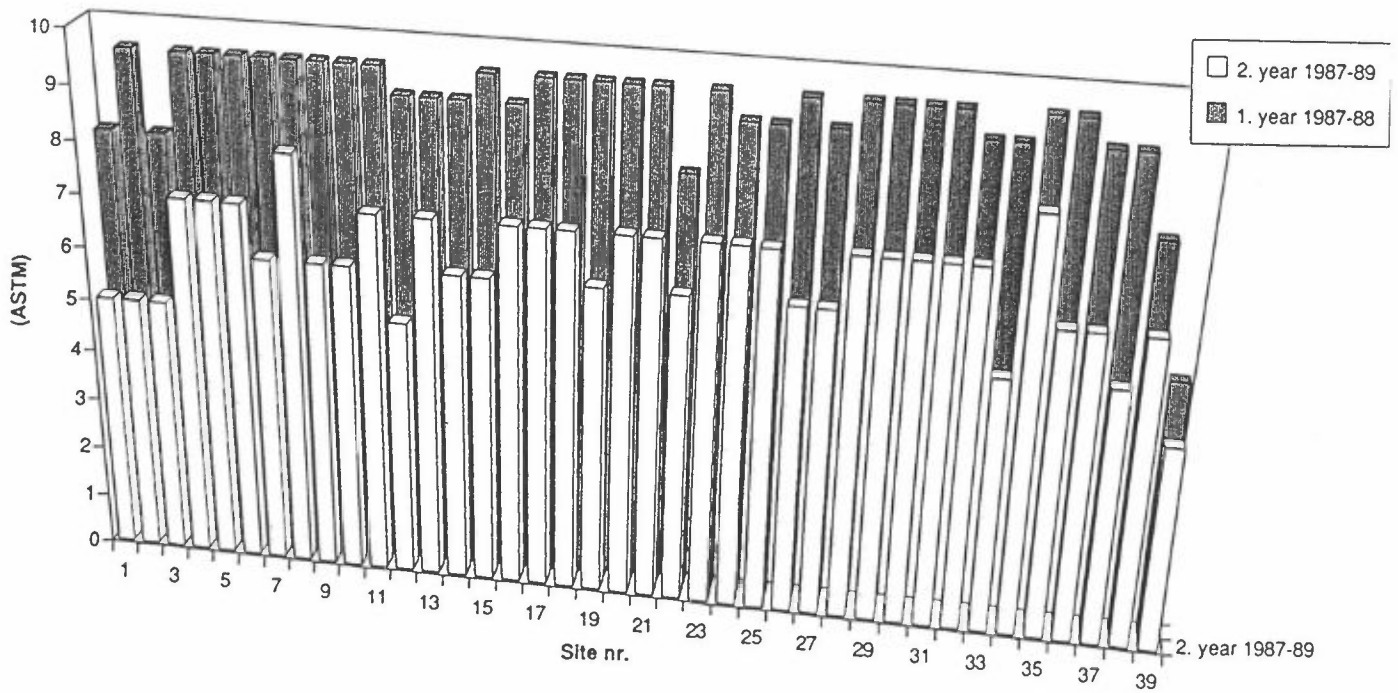
Chalking, Type K

Figure 8: Chalking results for acrylate paint after 1 and 2 years.

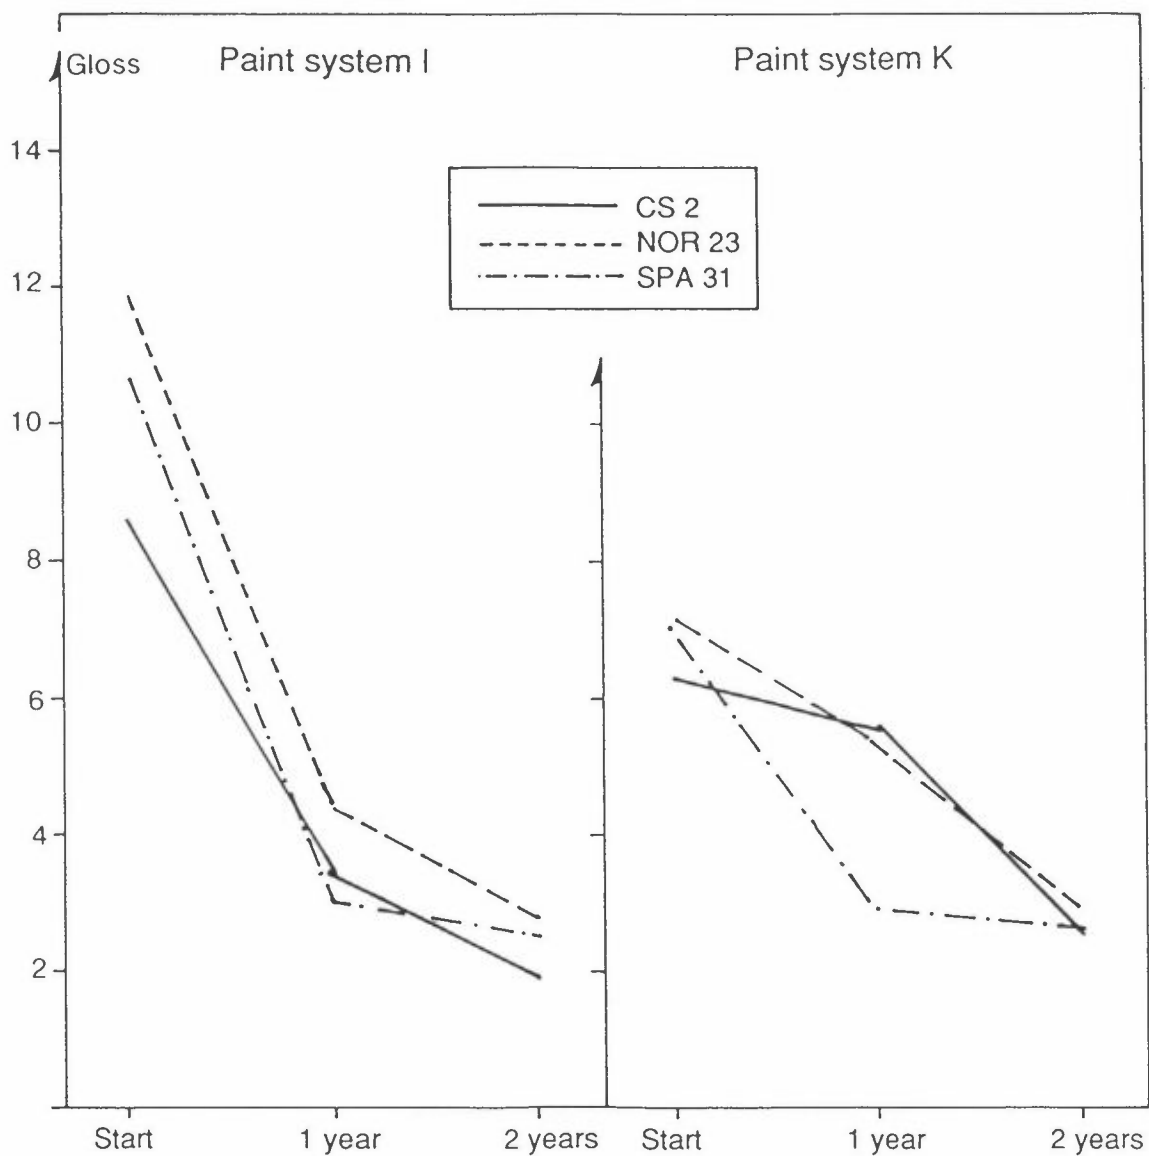
Figure 9: Gloss results for the test sites CS 2 Kasperske Hory, NO 23 Birkenes and SPA 31 Madrid after 1 and 2 years.

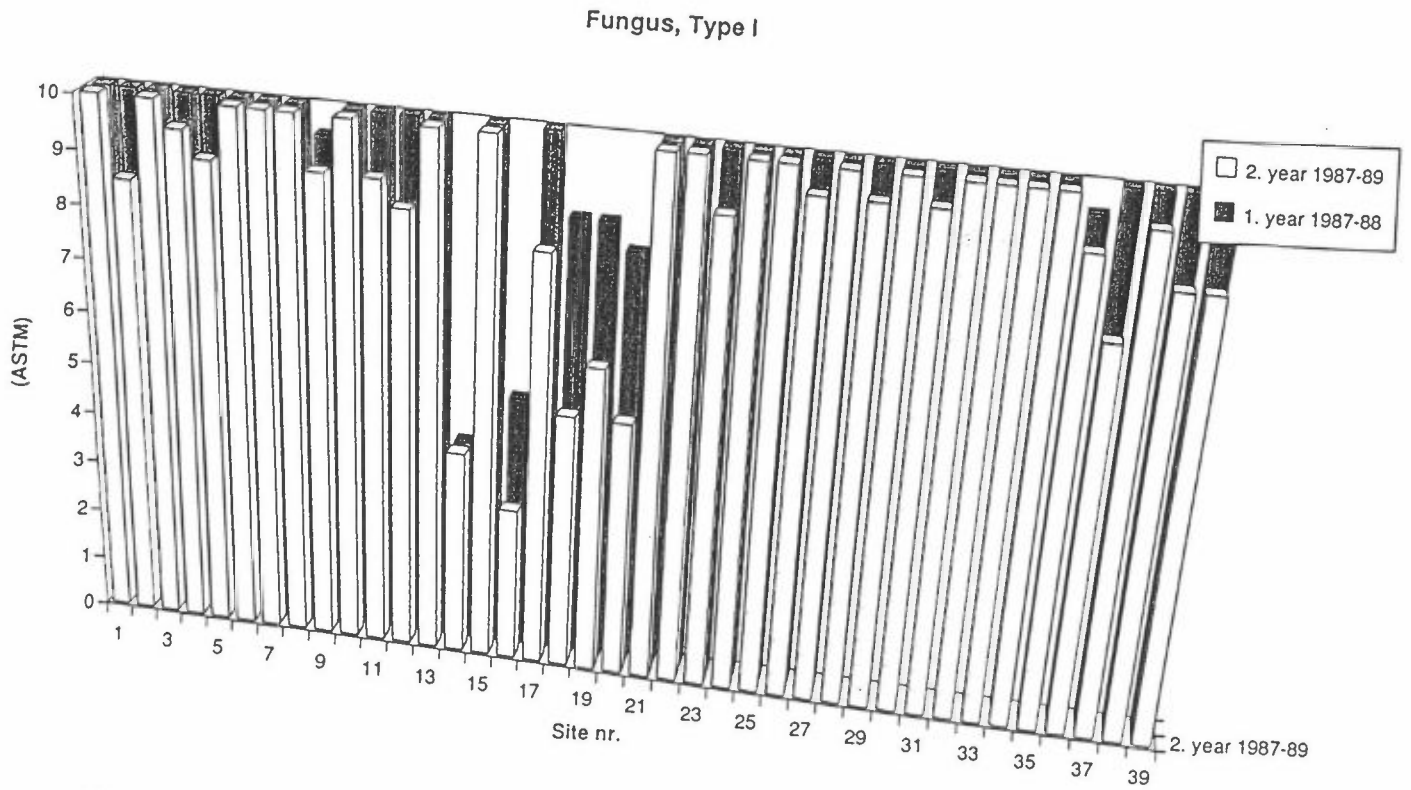
After one year of exposure it was observed fungi on 7 panels and after two years on 22 panels. The panels in Venice were worst both after one and two years (RN=3). The rural site Casaccia had RN=4 after two year and the two sites in Netherland Eibergen and Wynandsrade had RN=5. The fungi found were always of the dark surface type.

Figure 10: Fungi results for alkyd paint after 1 and 2 years.

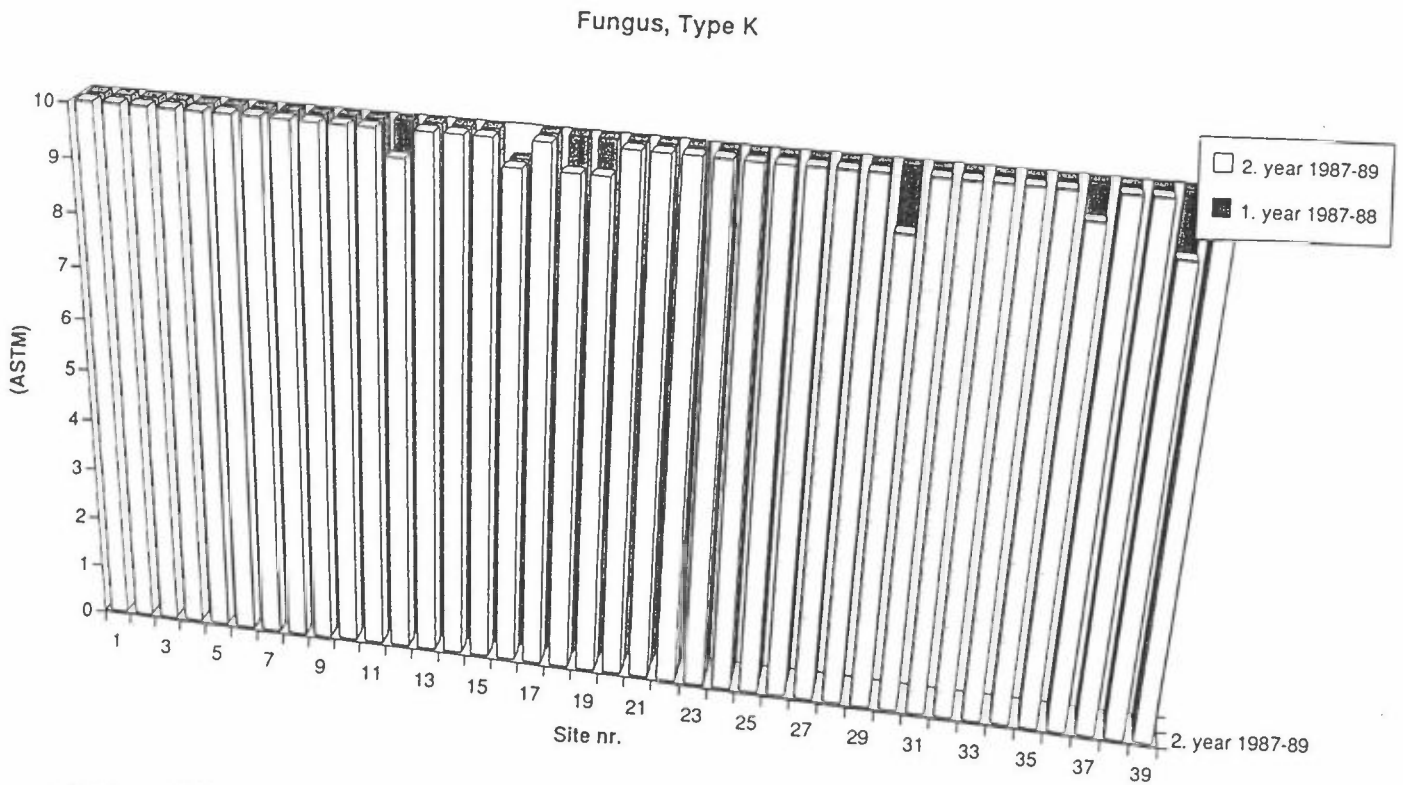
After the first year of exposure fungi were only observed on one panel, that was ITA 16. The next year we got 7 fungus-contaminated panels, but non had much of it. The lowest rating RN=9 was given to the very clean site UK 29 and to the industry site USA 39

Figure 11: Fungi results for acrylate paint after 1 and 2 years.
