NILU : OR 24/93  
REFERENCE : O-8208  
DATE : MAY 1993  
ISBN : 82-425-0479-2

# **International Co-Operative Programme on Effects on Materials, including Historic and Cultural Monuments**

**Evaluation of decay of painted systems for wood,  
steel and galvanized steel after 4 years exposure**

**Jan F. Henriksen, Kari Arnesen, Odd Anda and Arild Rode**

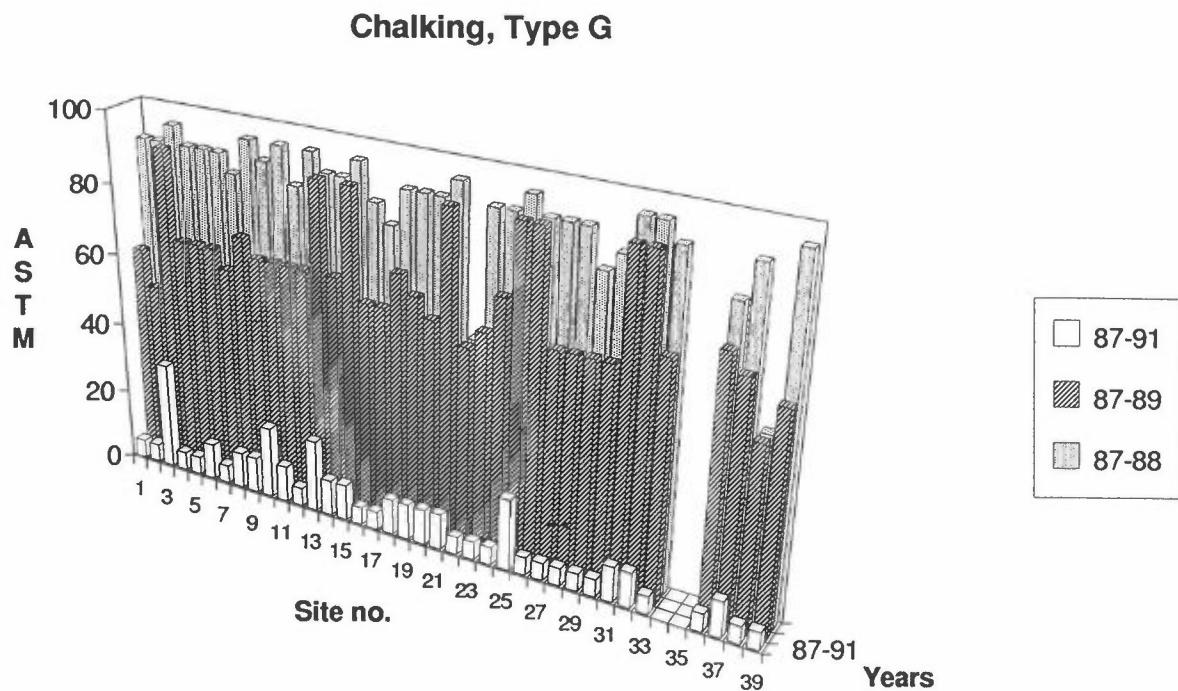
Figure 1.1: Chalking results for alkyl melamine paint after 1, 2 and 4 years.

Fig. 1.1 and 1.2 show a significant increase in chalking from previous years. Particularly alkyd melamine (type G) was effected and has reached the limit for the evaluation method, but also the silicon alkyd showed strong chalking. For the evaluation after four years the same flexible tape (Scotch electric insulating tape, black) was used as for the second year's evaluation.

After 4 years 33 panels had reached R=1.0 or 0.5. The best result was observed at the industry site Kopisty (CS3) with a rating of RN=3.0.

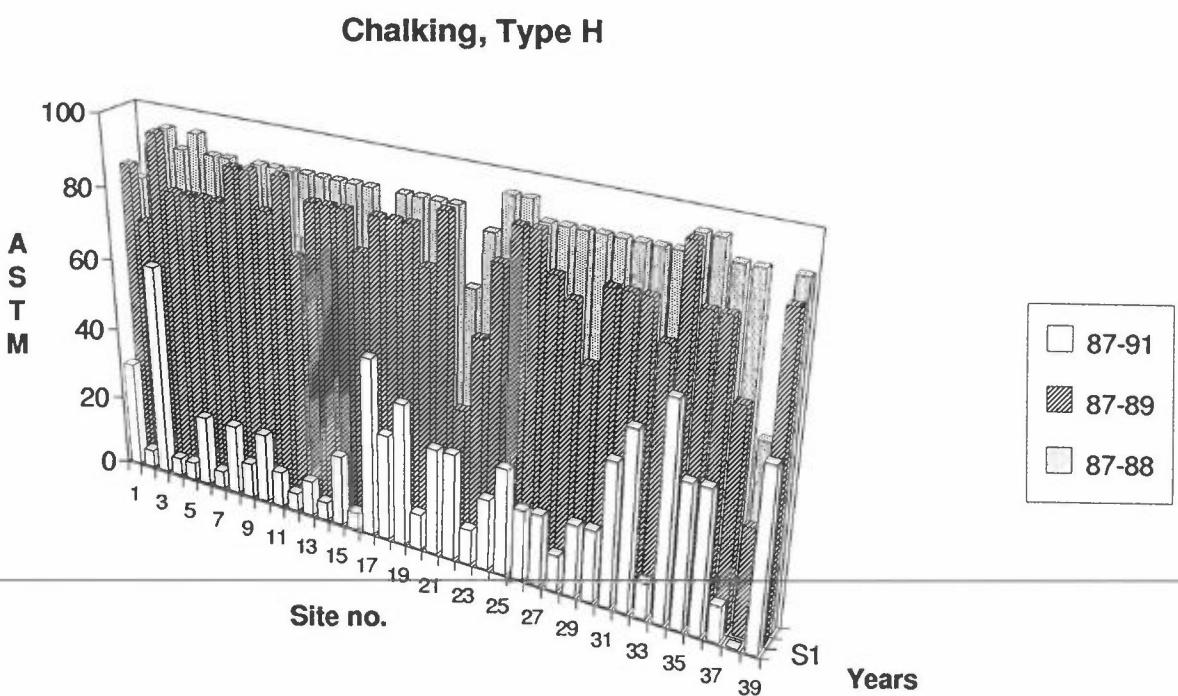
Figure 1.2: Chalking results for silicon alkyl paint after 1, 2 and 4 years.

All the panels showed substantial chalking after four years, but generally less than for the G-panels. 16 of the sites had a rating of 1.0 or lower. The highest rating RN=6.0 was observed at Kopisty (CS3) and Moscow (RUS34).

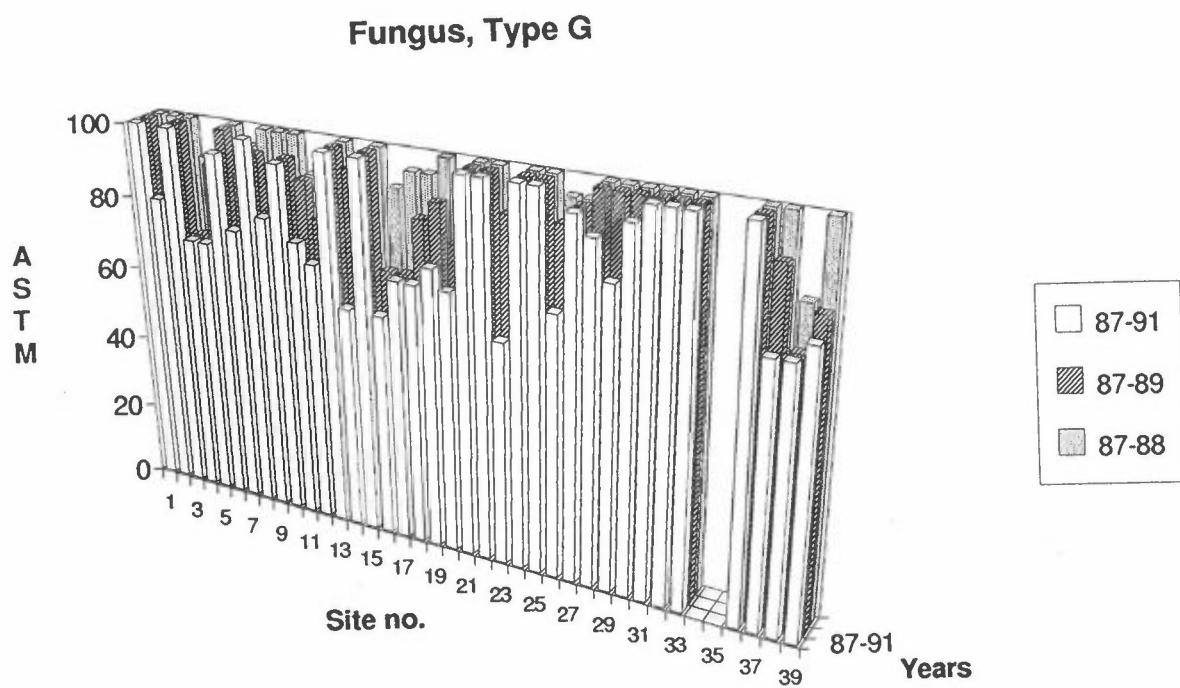
Figure 1.3: Fungus results for alkyd melamine paint after 1, 2 and 4 years.

The results of the evaluation of the fungi are shown in fig. 1.3 and 1.4. No identification of the types has been done so far. Silicon alkyd is more effected by fungi than alkyd melamine.

After four years fungi were observed on 24 panels, and ITA14 (Casaccia) and ITA16 (Venice) got the lowest rating with RN=6.

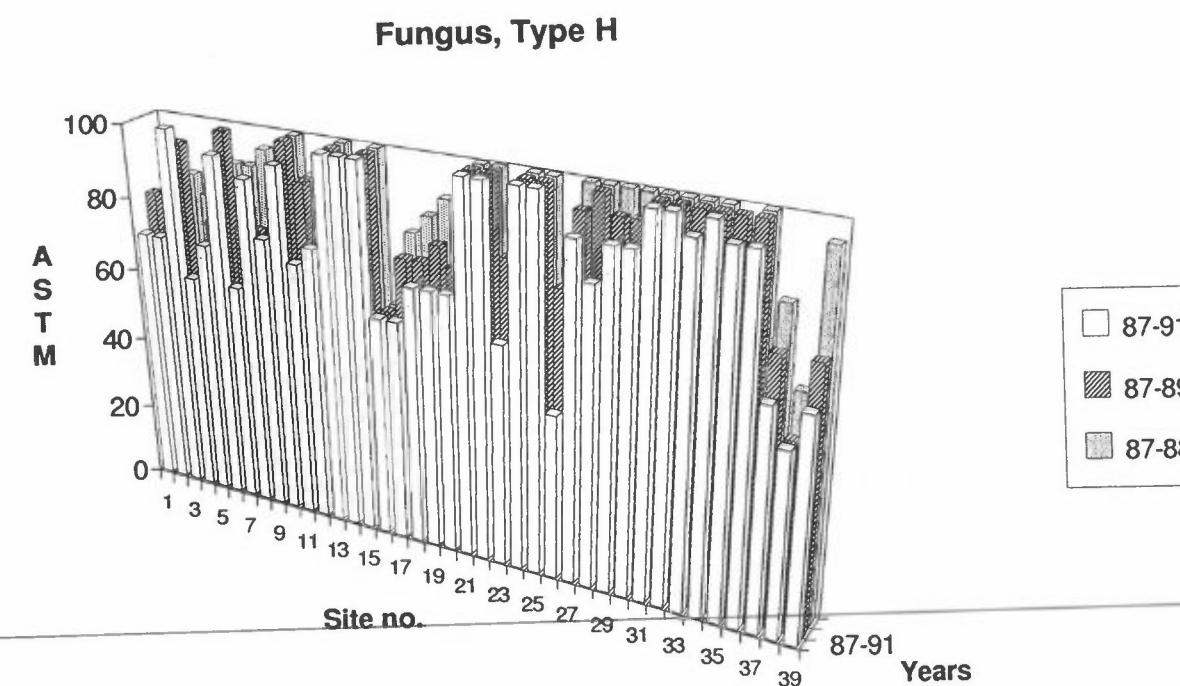
Figure 1.4: Fungus results for silicon alkyd paint after 1, 2 and 4 years.

28 panels were fungus infected after four years. The lowest RN after four years had the rural site SWE26 (Aspvreten) with RN=4.5.

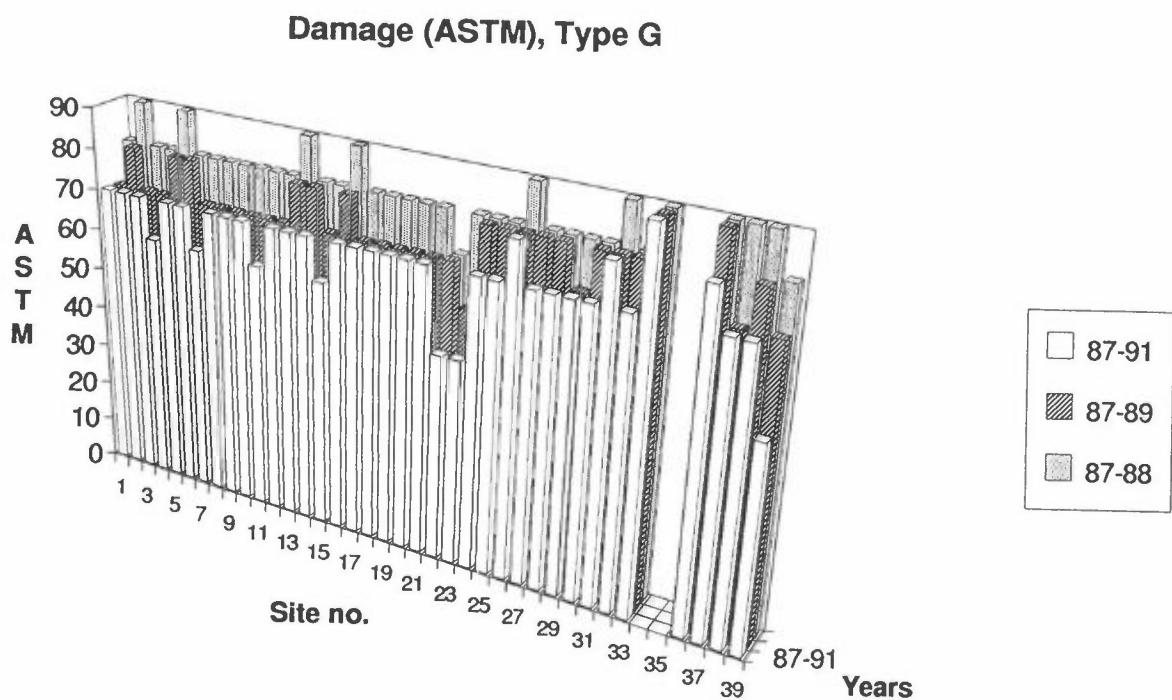
Figure 1.5: Results of the damage in and near the cut for alkyd melamine paint after 1, 2 and 4 years.

The strongest effects are observed at the industry sites, particularly for system H. However, even the rural sites in Scandinavia have significant corrosion around the cut.

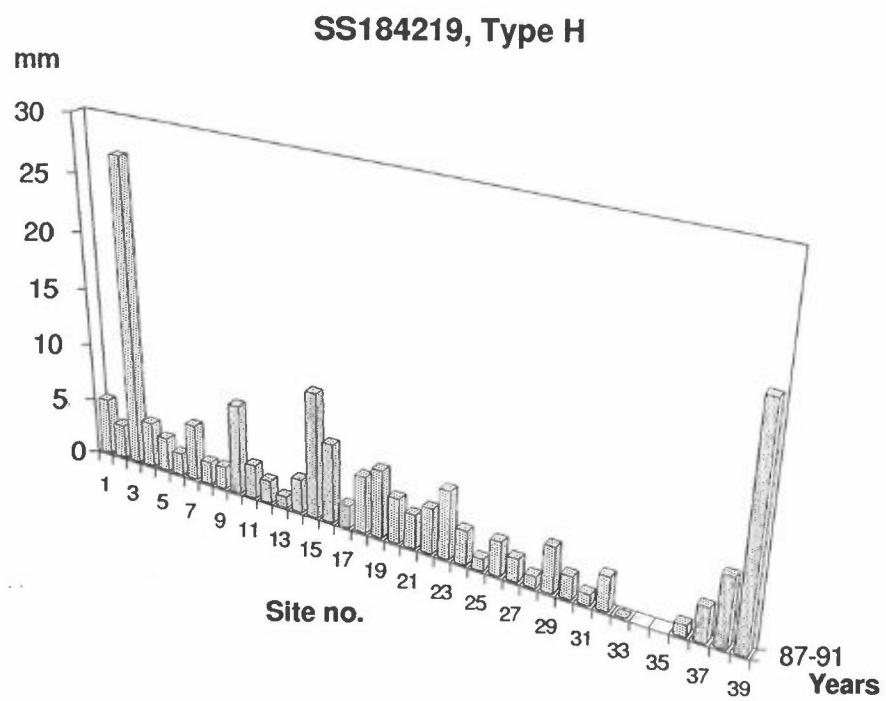
*Figure 1.7: Results of the damage in and near the cut for silicon alkyd paint after 4 years evaluated after the Swedish standard SS 184219.*

The four year results for damage around the cut were also evaluated according to the Swedish standard SS 184219, where the spread from the cut in millimeter is the evaluation criteria. For this reason we have also given the best equations for the correlation between the damage and the environmental parameters in Table 3. The correlation coefficients calculated according to ASTM and SS are close to the same value as expected. Highest correlation is observed for SO<sub>2</sub> and TOW x SO<sub>2</sub>.

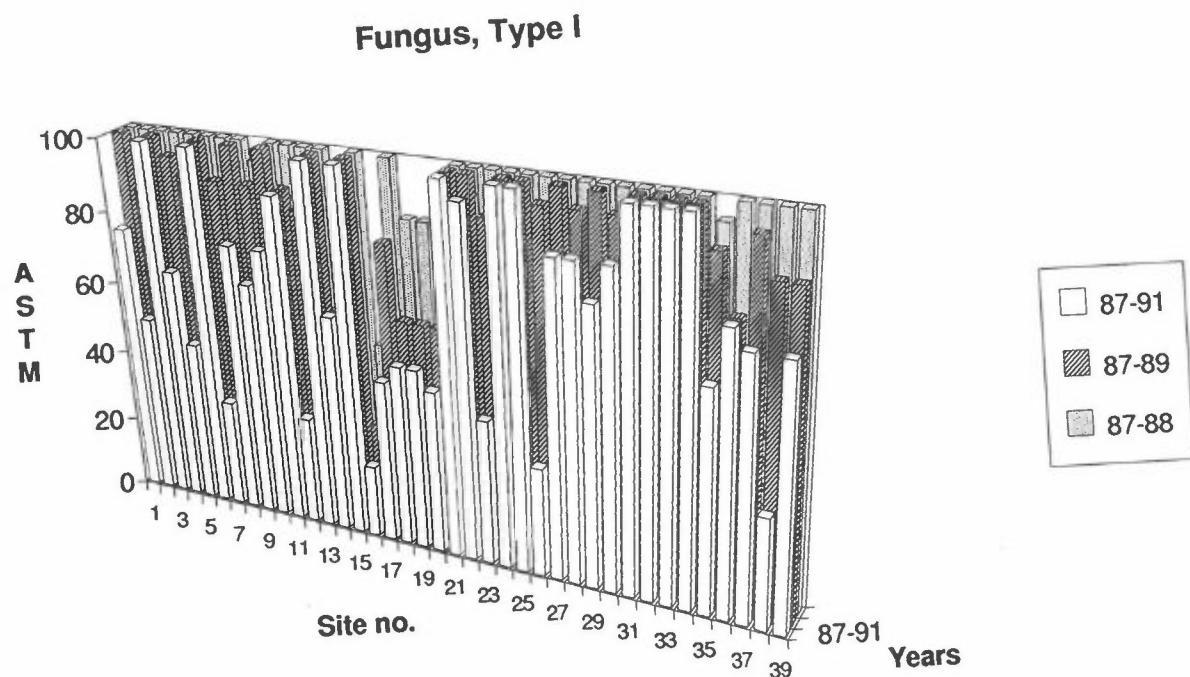
Figure 1.10: Fungus results for alkyd paint after 1, 2 and 4 years.

After four years of exposure fungus was observed at 28 test sites. The panels in Venice (ITA16) were worst both after one, two and four years (RN=2.0). The fungi found were always of the dark surface type (mildew).

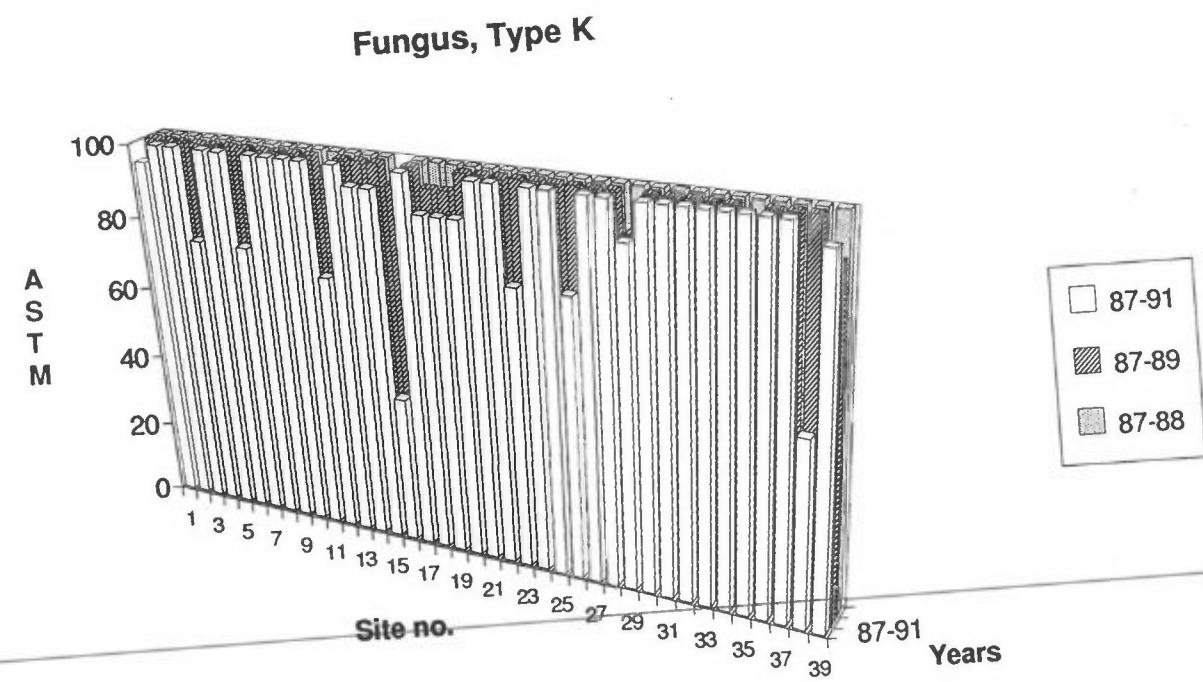
Figure 1.11: Fungus results for acrylate opaque stain after 1, 2 and 4 years.

After four years of exposure fungi were only observed on 15 panels. The lowest rating was given to the panels in Venice RN=4.0.
