NILU : OR 42/98  
REFERENCE : O-8208  
DATE : AUGUST 1998  
ISBN : 82-425-1000-8

# **International Co-operative Programme on Effects on Materials, including Historic and Cultural Monuments**

**Evaluation of decay of painted systems for wood,  
steel and galvanized steel after 8 years exposure**

**Jan F. Henriksen, Odd Anda, Alena Bartonova, Kari Arnesen  
and Unni Elvedal**

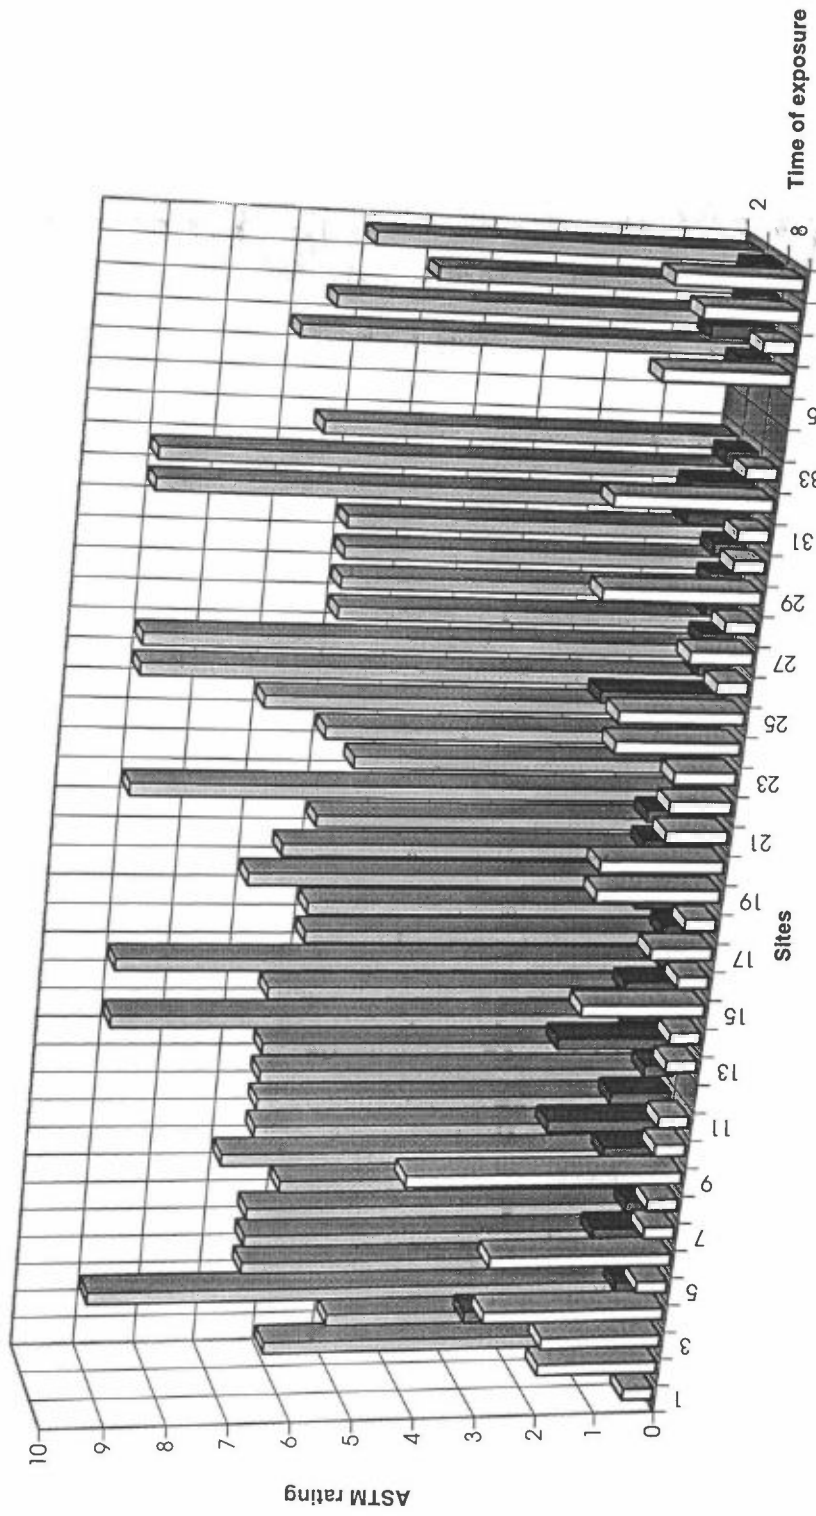
Totally we observed more chalking on type H than on type G after eight years. After four years it was vice versa.

Figure 1.1: Type G. Chalking after 2, 4 and 8 years of exposure.

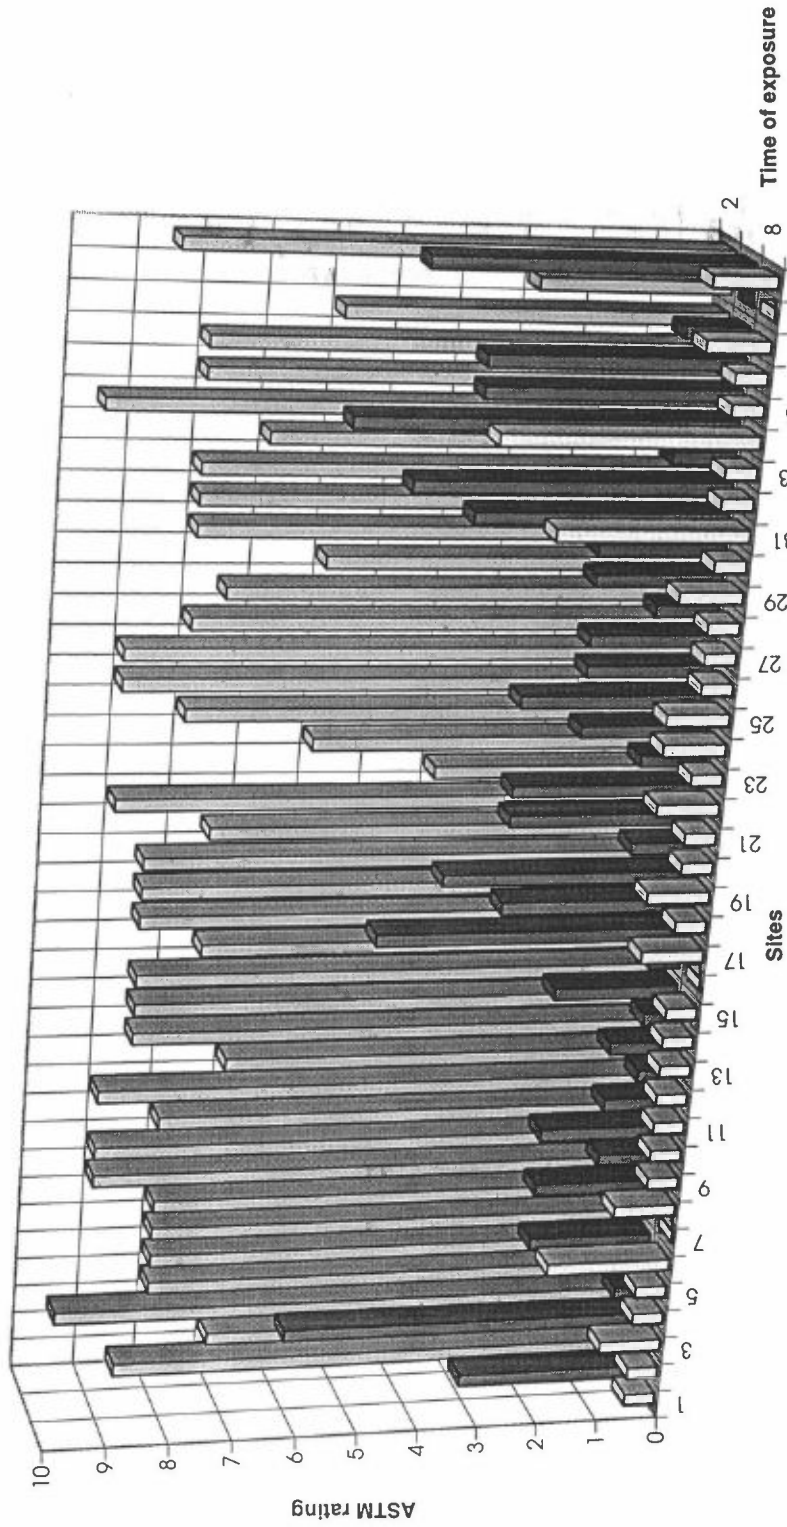
Figure 1.2: Type H. Chalking after 2, 4 and 8 years of exposure.

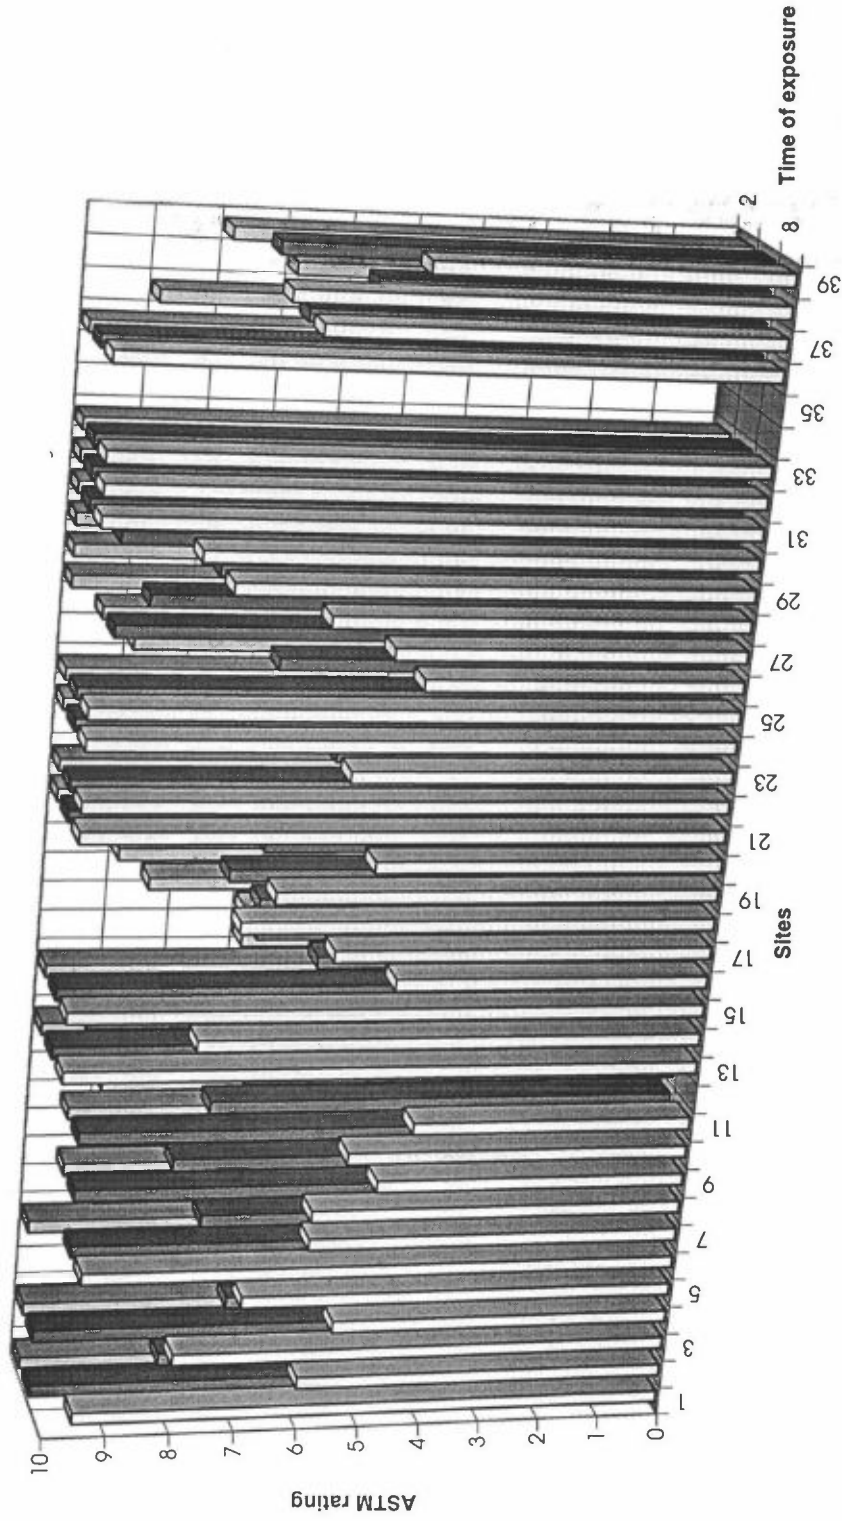
After eight years fungi were observed on 26 panels or sites. That is two panels more than after four years. This means that 10 panels are free from fungi so far. Many of these panels are found in Spain, Sweden and Norway.

Figure 1.3: Type G. Fungus after 2, 4 and 8 years of exposure.

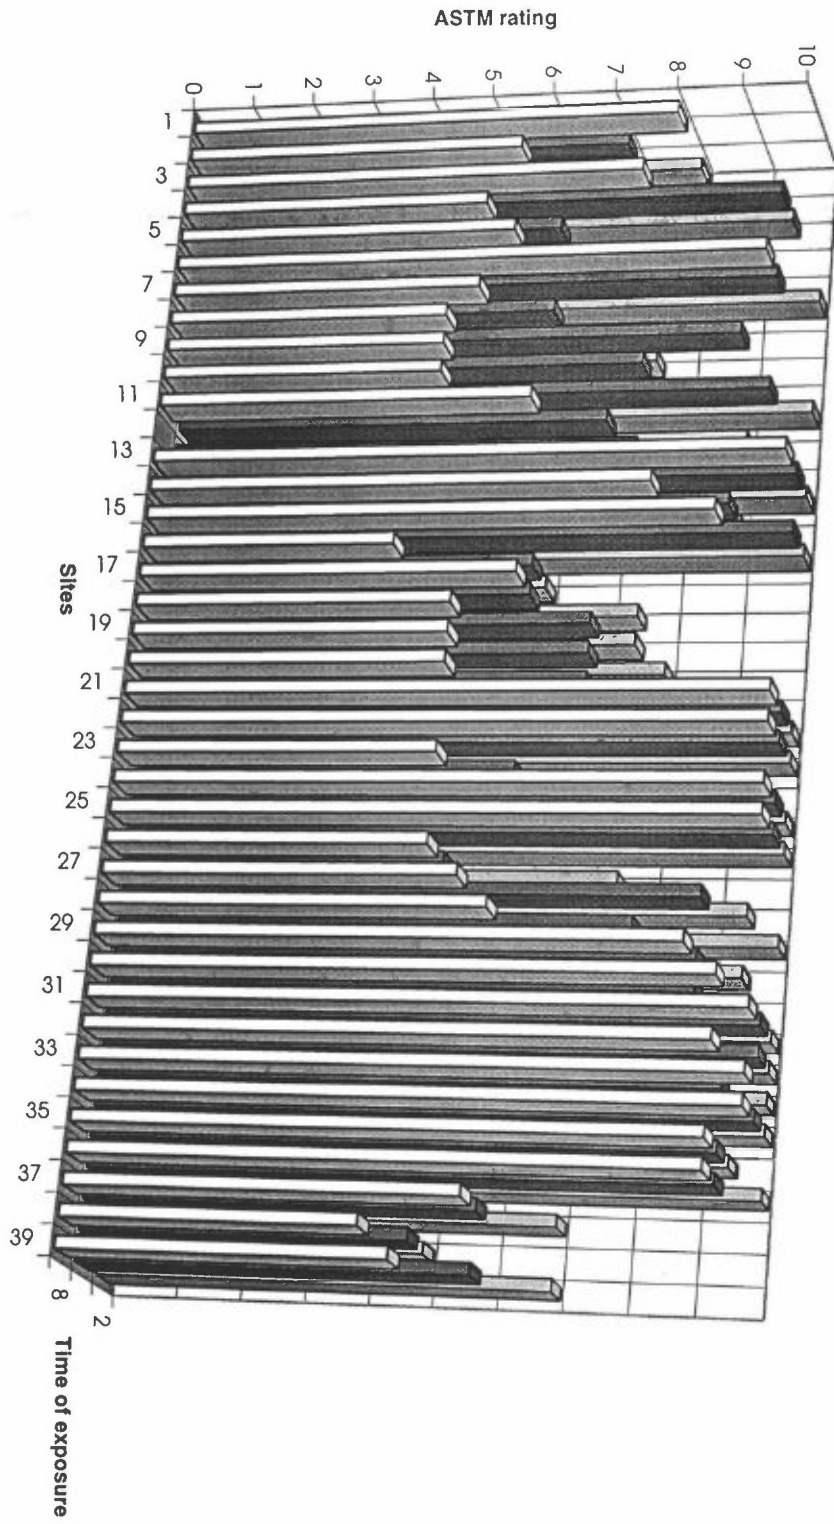
Lowest RN (= 4) we found in the site ITA 16, but the RN were also low in FRG 8, FRG 9 and FRG 10 and USA 38, all with RN = 4.5.

Figure 1.4: Type H. Fungus after 2, 4 and 8 years of exposure.

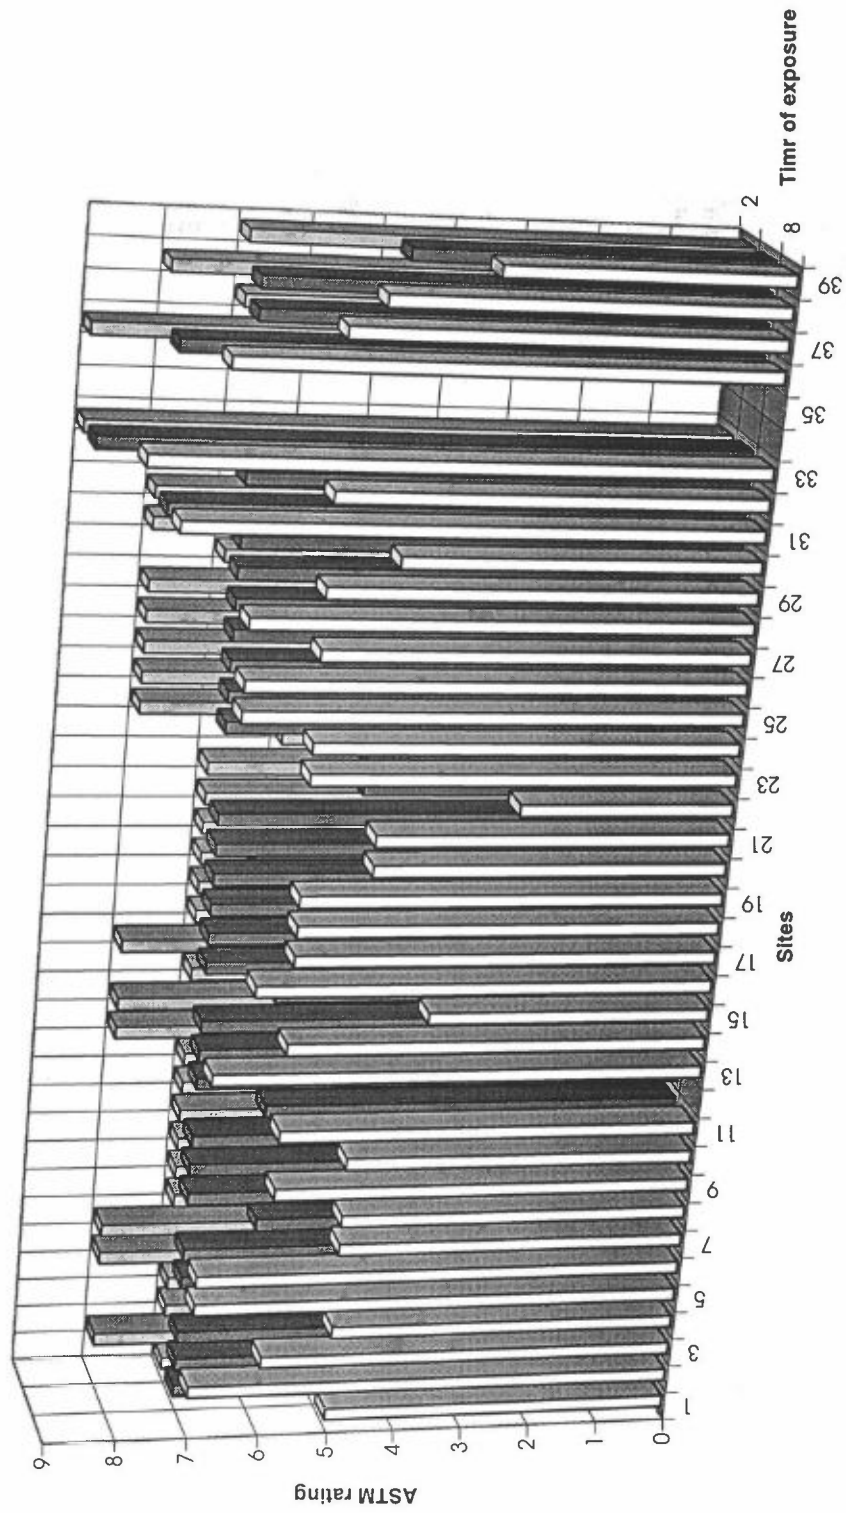
Best results we found in SPA 33 (RN = 9), ITA 13 and POR 36 (RN = 8).

Figure 1.5: Type G. Damage from cut after 2, 4 and 8 years of exposure.

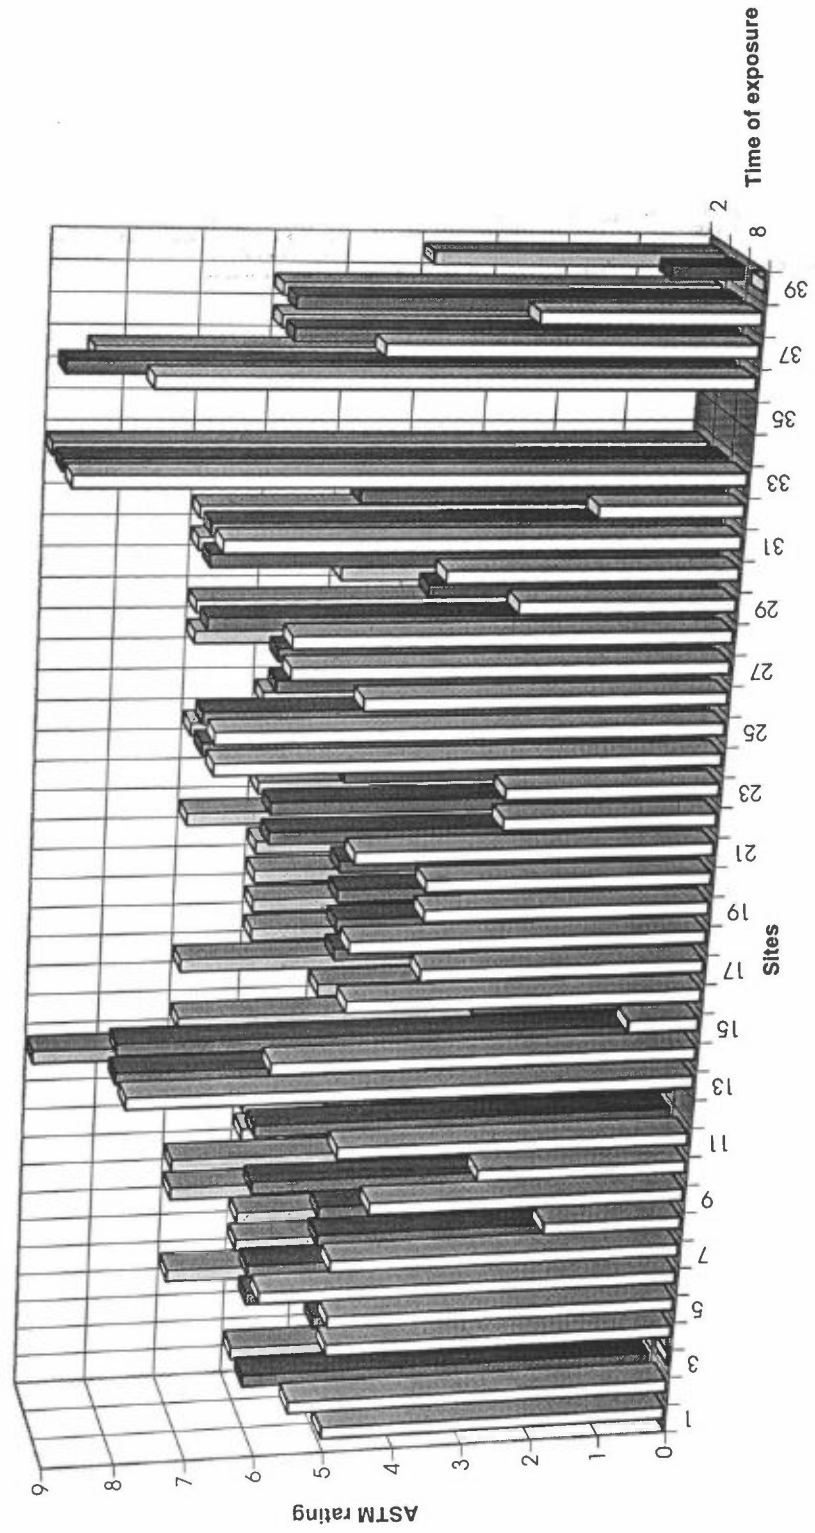
The panels on following sites had serious damages in cut: CS 3 and USA 39 (RN = 0), ITA 15 (RN = 1), FRG 8 and SPA 32 (RN = 2), NOR 22 and NOR 23, UK 29 and USA 38 (RN = 3).

Figure 1.6: Type H. Damage from cut after 2, 4 and 8 years of exposure.

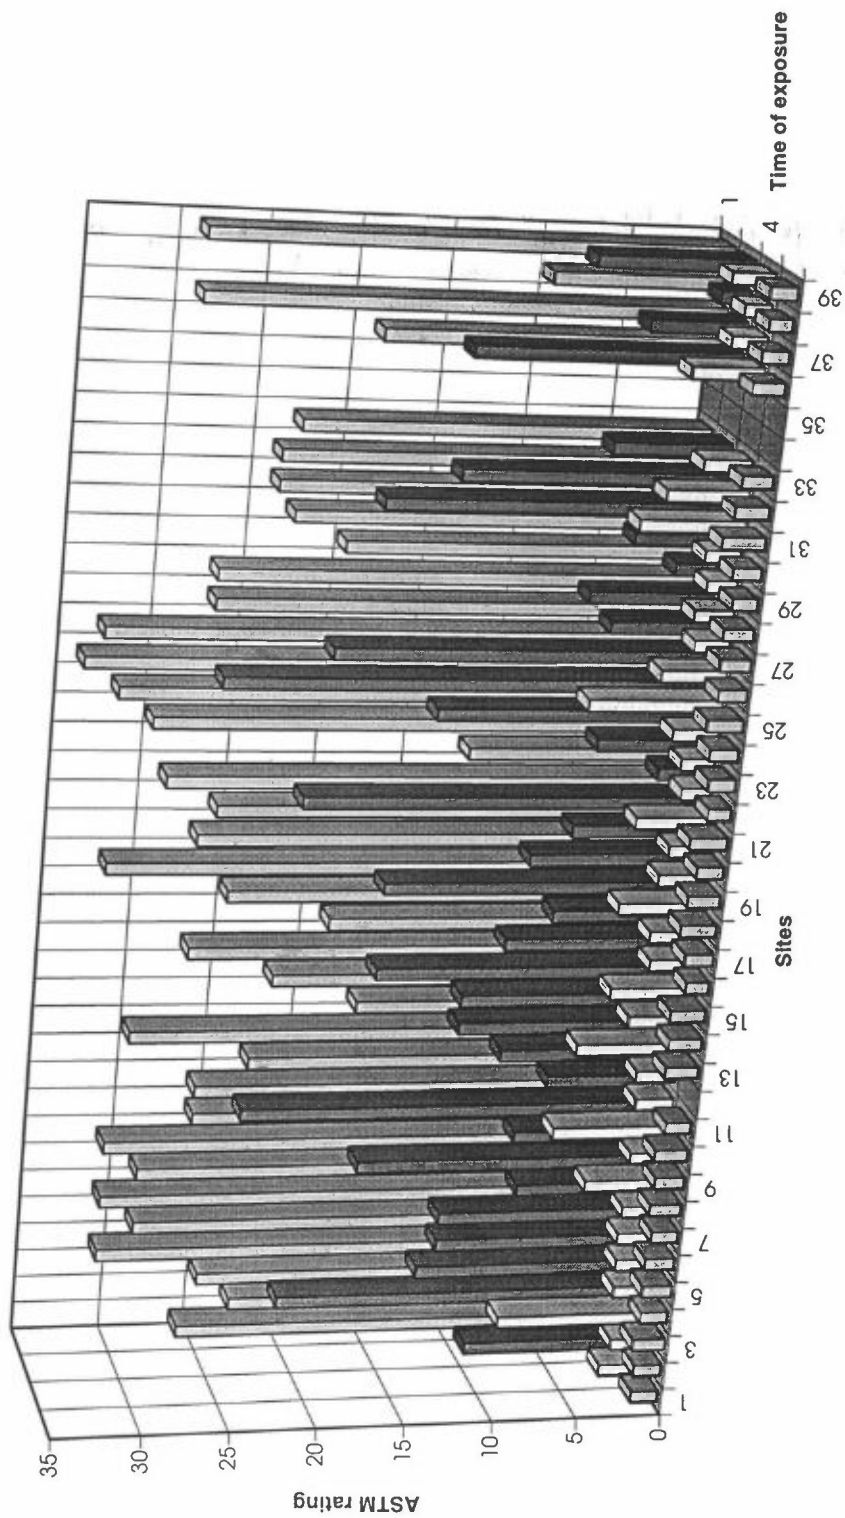
Very little gloss is now measured on these panels. The site SPA 31 had gloss value of 2.4%. All the other sites had values of 2 or less. The lowest values we found in USA 38, UK 29 and NOR 22.

Figure 1.7: Type G. Gloss after 1, 2, 4 and 8 years of exposure.

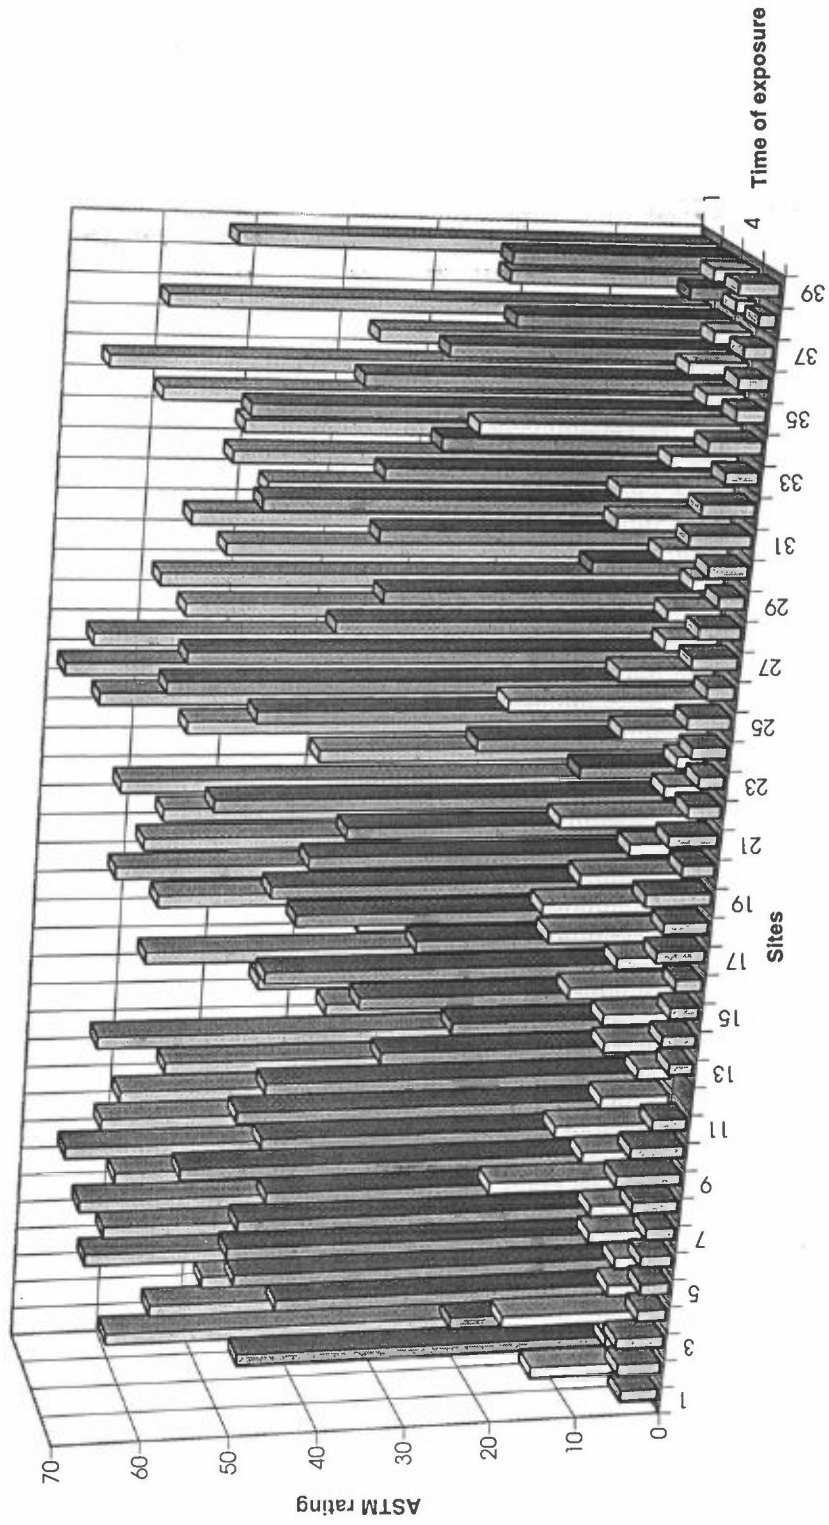
Most gloss we could observe in NL 19, FRG 9 and SPA 31. These sites were the only ones where the gloss values were equal to or exceeded 7%. The lowest values were found in USA 38, NOR 23, UK 29 and ITA 13.

Figure 1.8: Type H. Gloss (front) after 1, 2, 4 and 8 years of exposure.

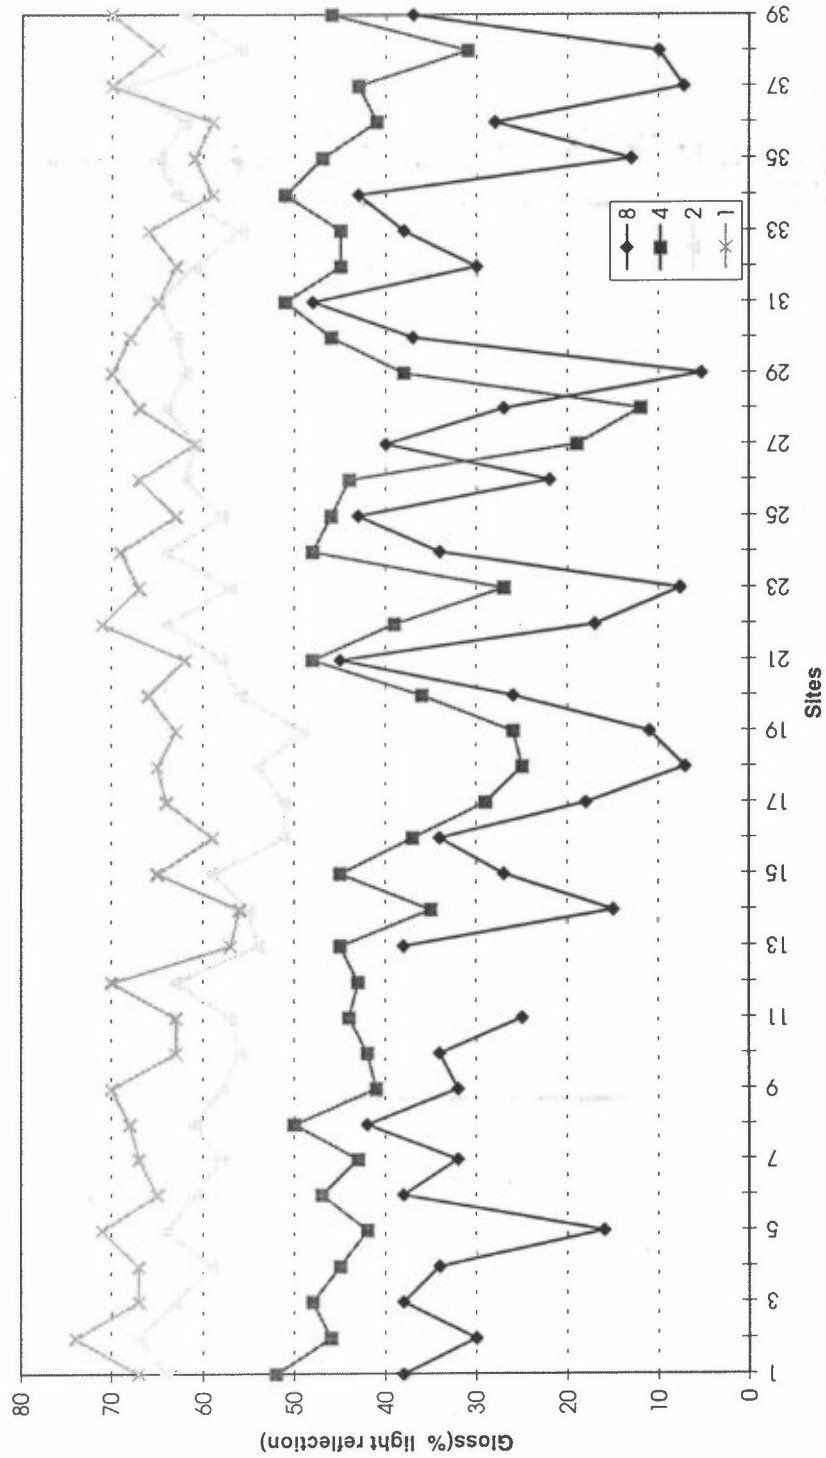
Least gloss we found in UK 29, NL 18, CAN 37 and NOR 23.

Figure 1.9: Loss of gloss on the backside of the alkyd painted panels after 1, 2, 4 and 8 years of exposure.

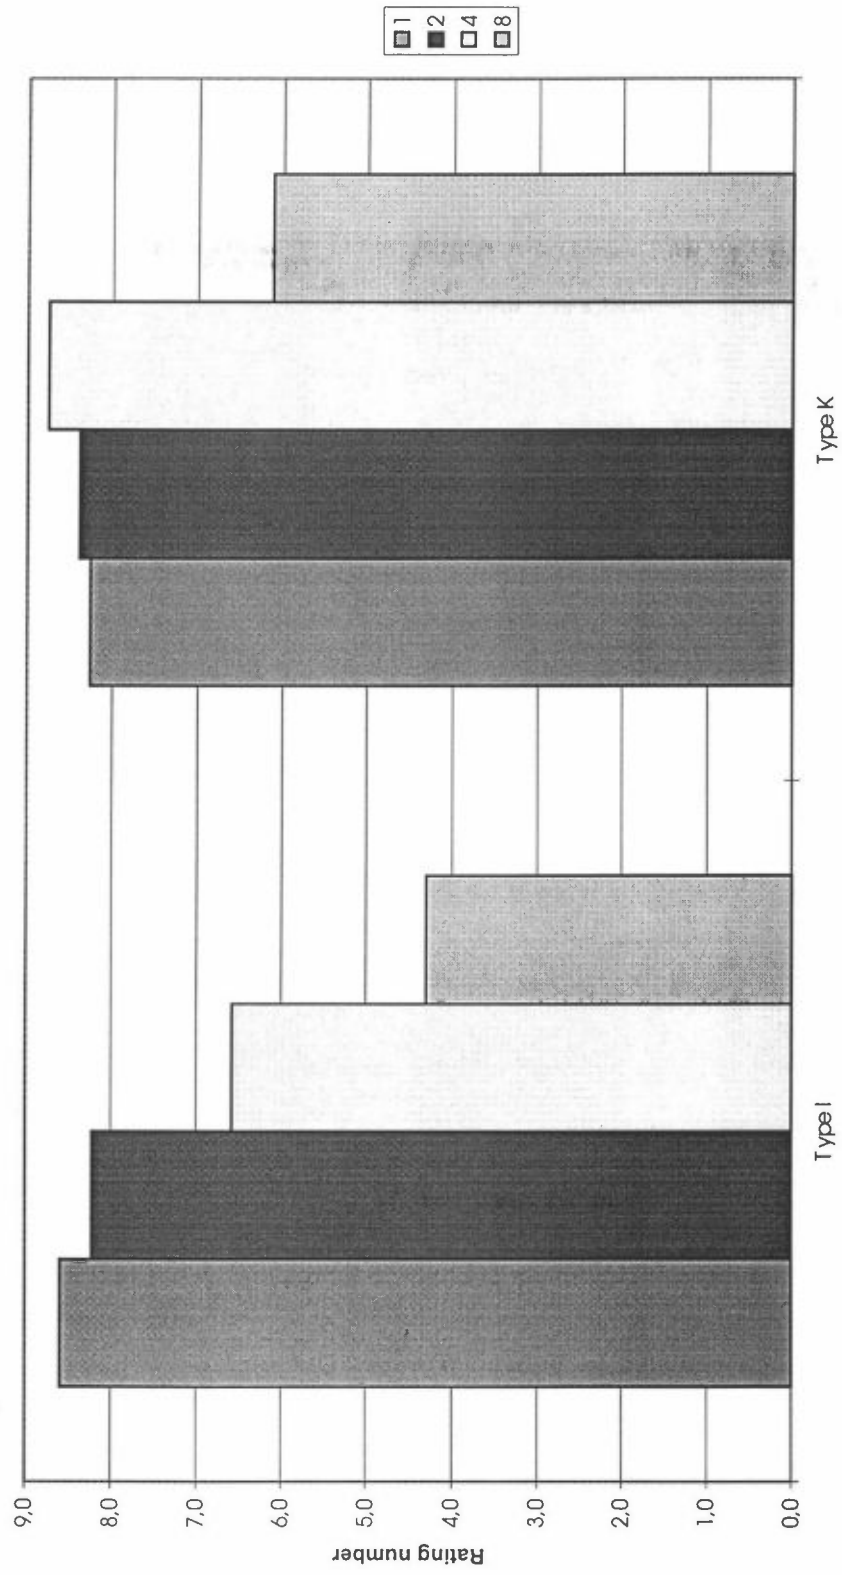
Figure 1.10: General appearance after 1, 2, 4 and 8 years of exposure (medium values, all sites included).

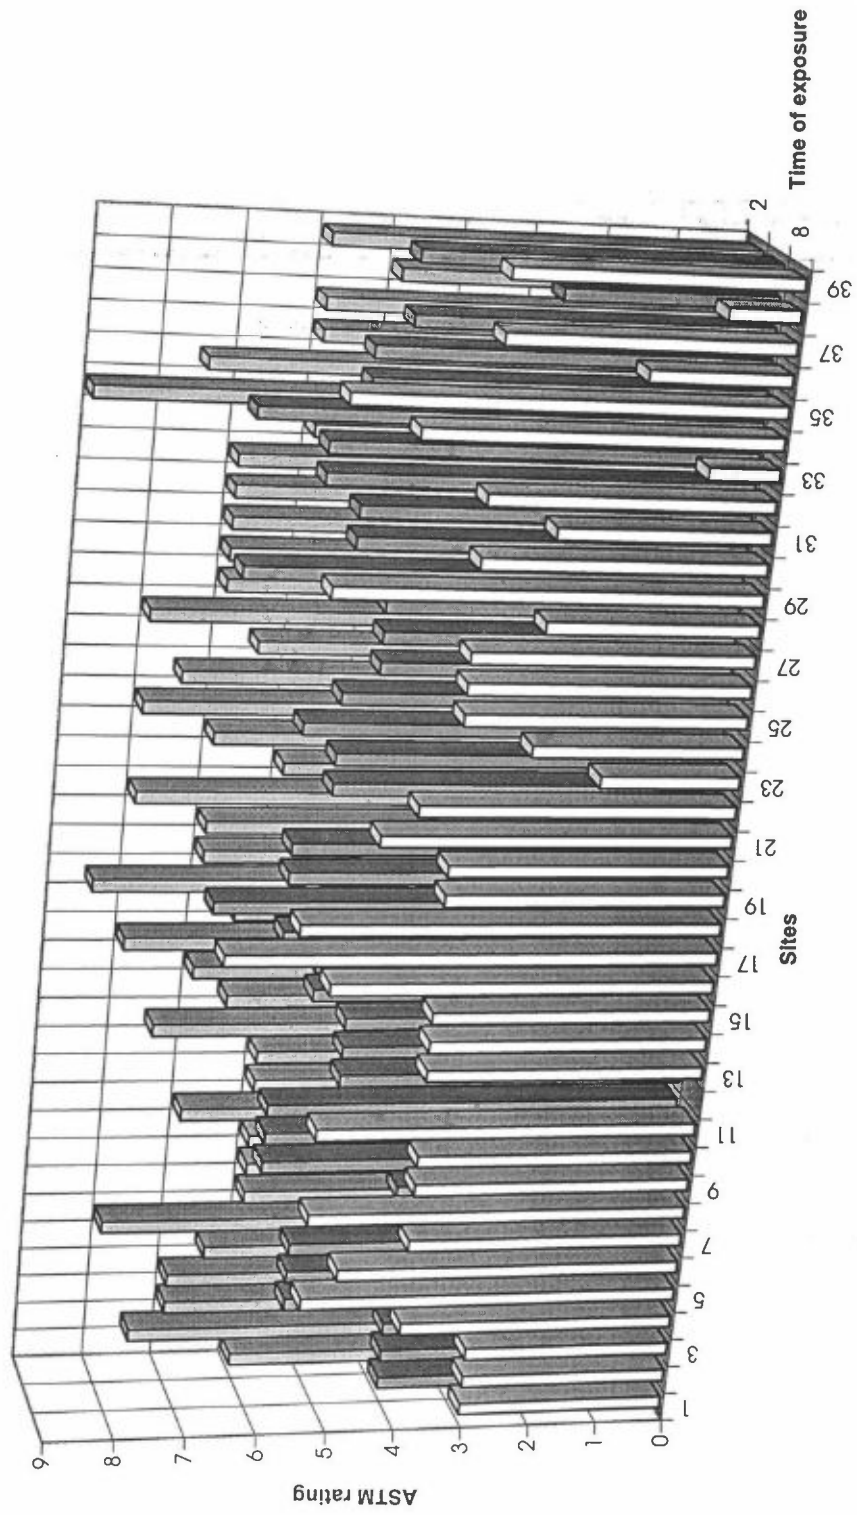
Figure 1.11: Type I. Chalking after 2, 4 and 8 years of exposure.

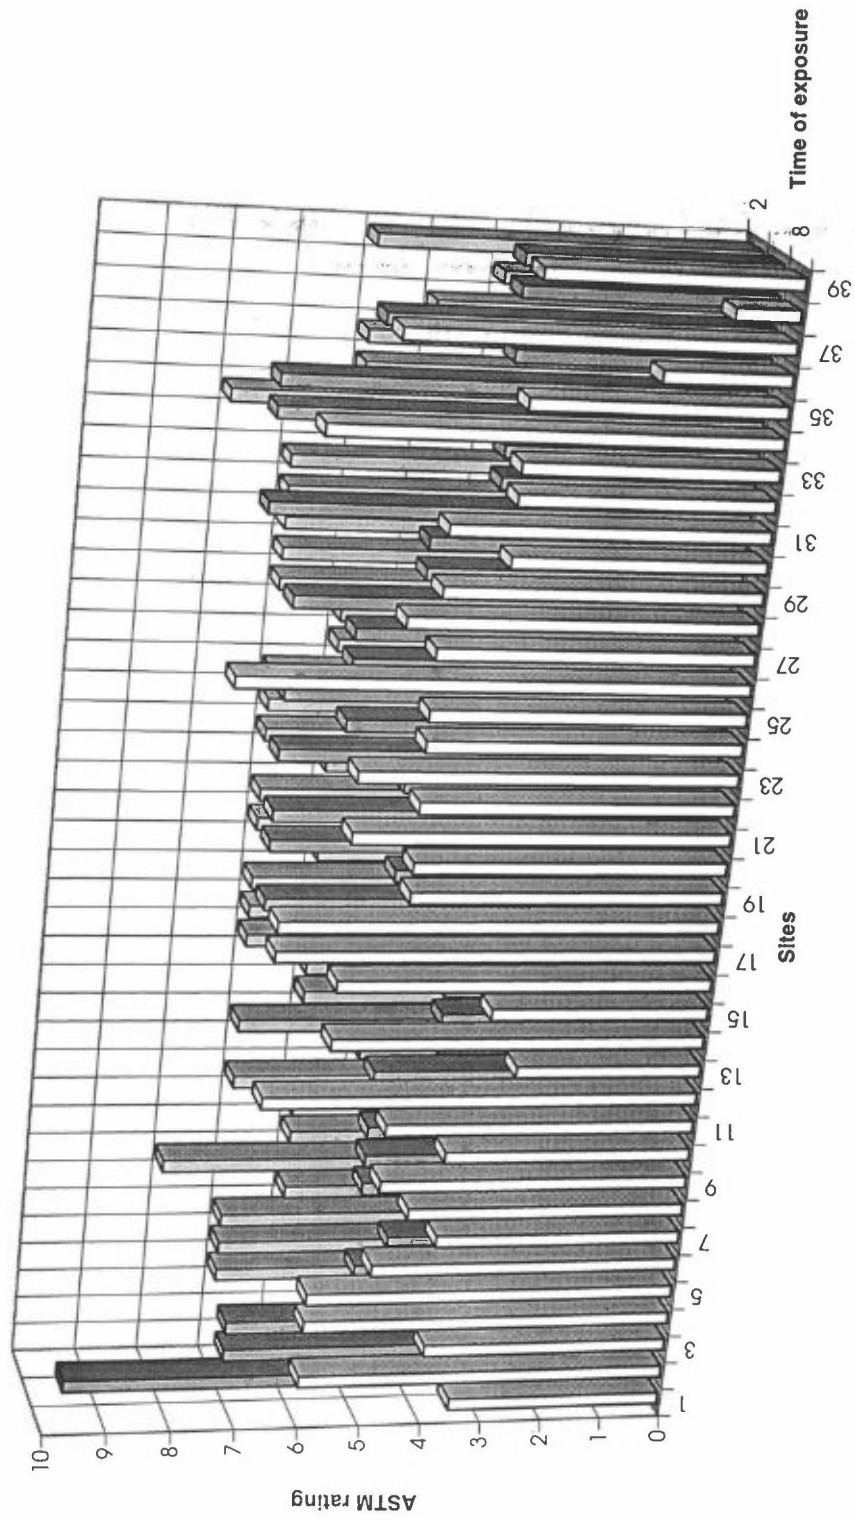
Most chalking we found on the panels at USA 38 (RN = 1) and POR 36 (RN = 2).

Figure 1.12: Type K. Chalking after 2, 4 and 8 years of exposure.

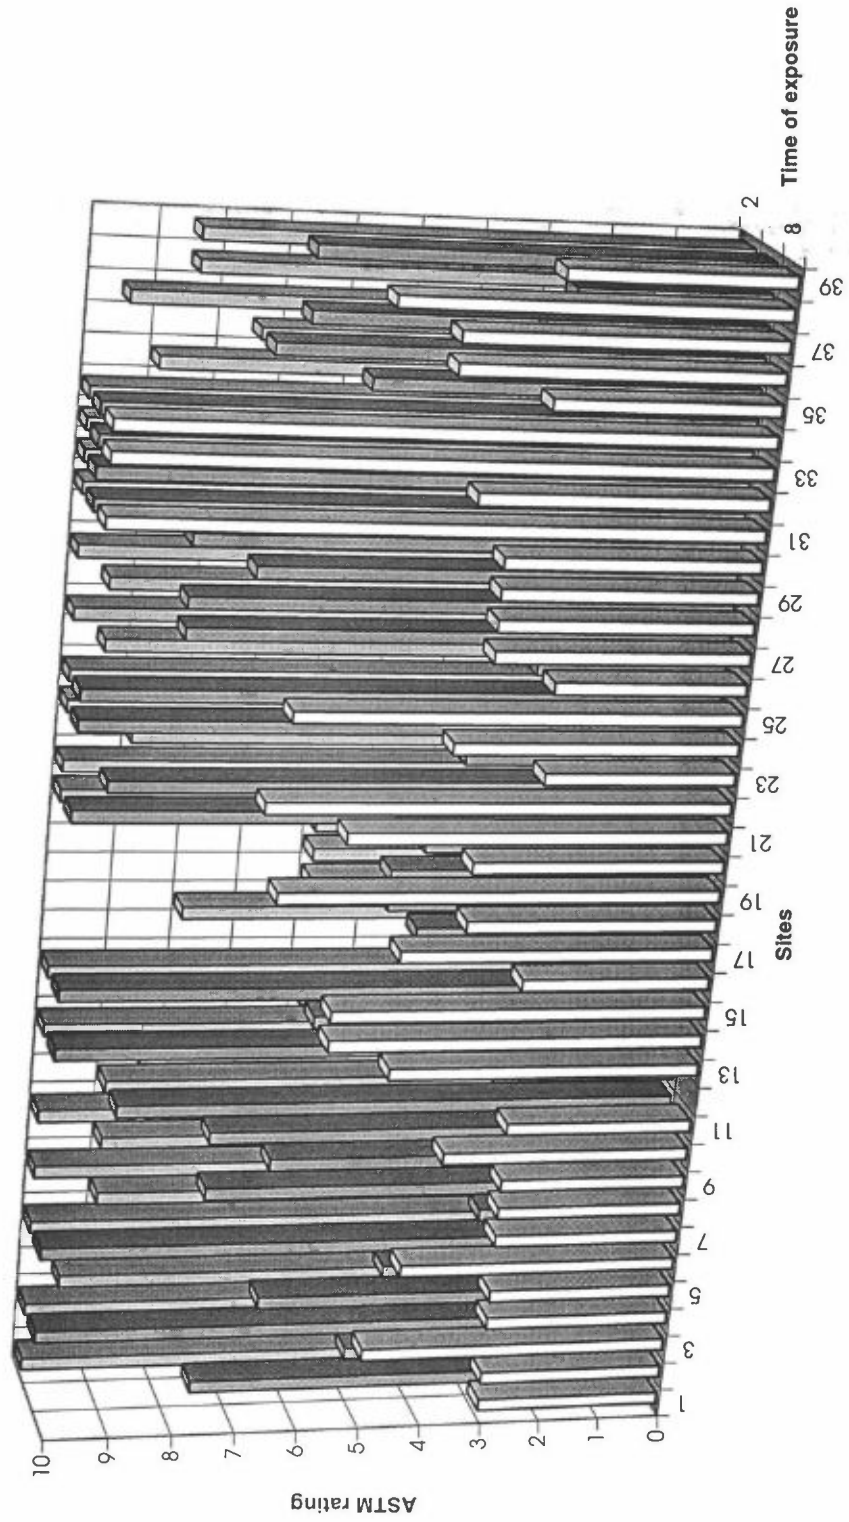
No fungus was found at the three sites SPA 31 and SPA 33 and RU 34.

Most fungus was observed at the sites in CZE, FIN and GER.

Figure 1.13: Type I. Fungus after 2, 4 and 8 years of exposure.

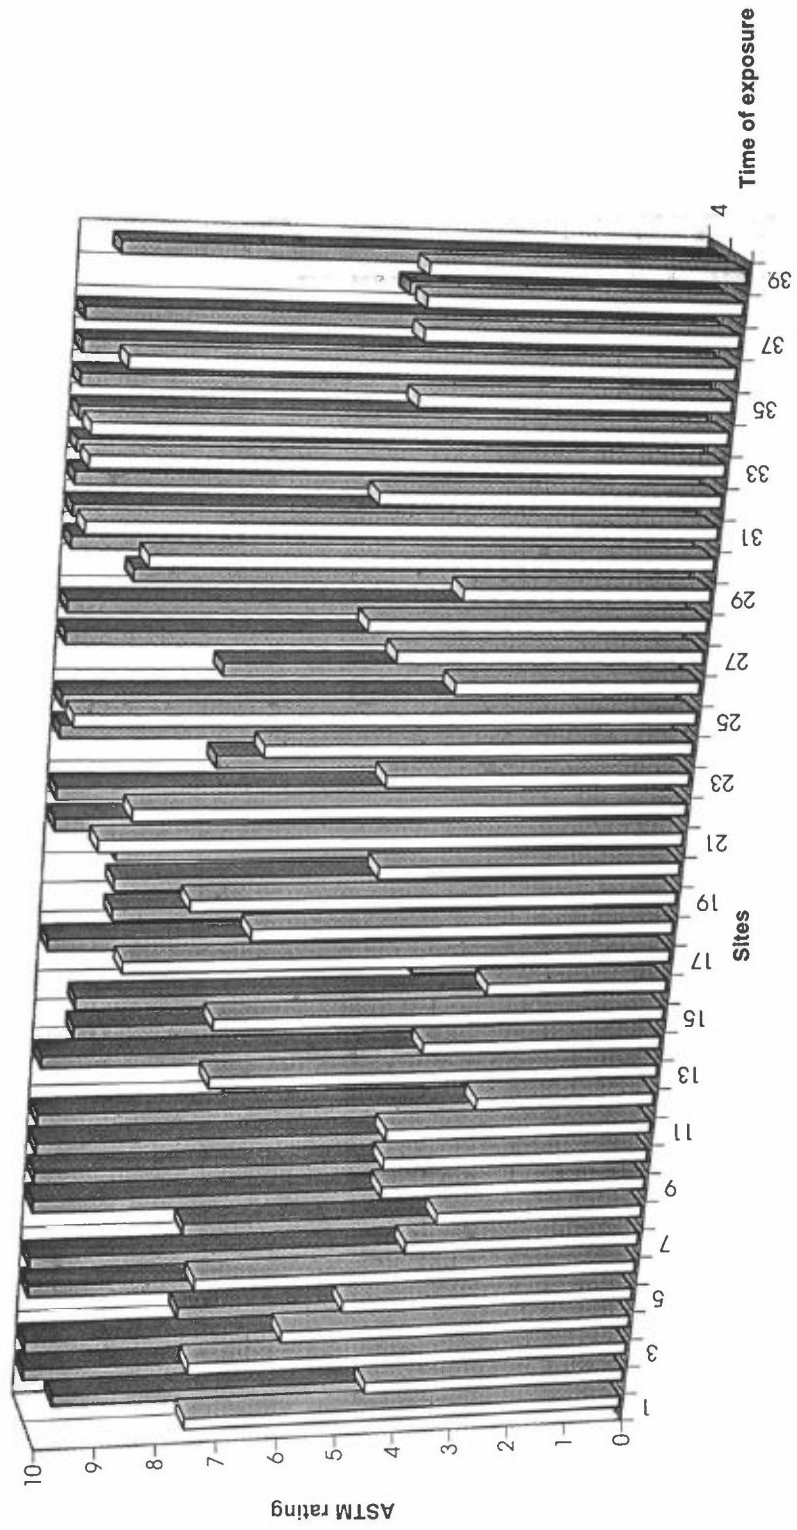
No fungus was found at these sites: SWE 25, SPA 31 and SPA 33 and RU 34. The three last ones are the same sites as for type I.

Figure 1.14: Type K. Fungus after 4 and 8 years of exposure.

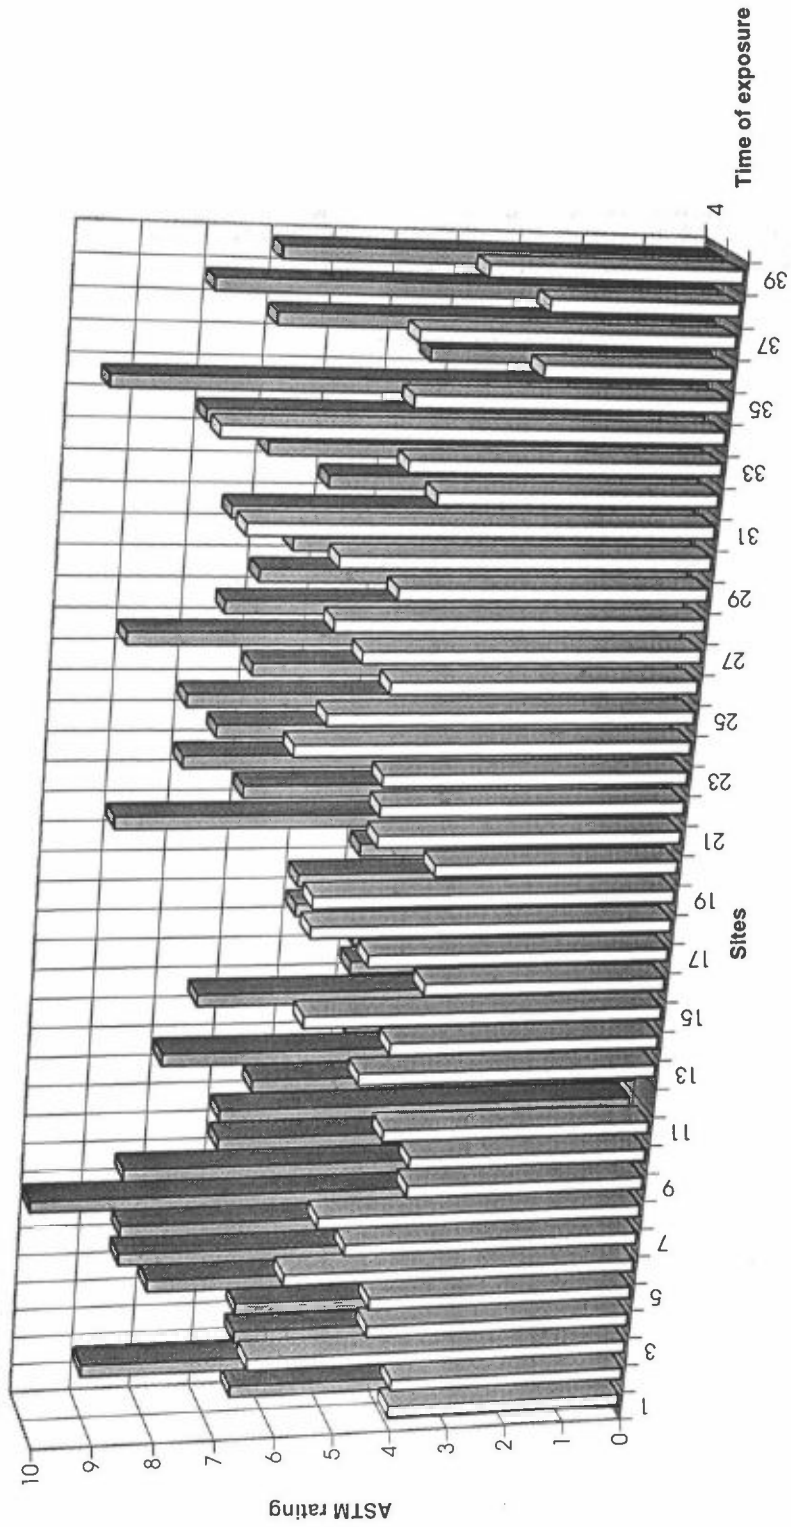
The panels at all the sites had cracking. Least cracking we observed at the sites RU 34 (RN = 8) and SPA 31 (RN = 7.5). At the site GER 8 the RN value had fallen from 10 to 5.5 from four to eight years of exposure, and for EST 35 was the corresponding fall from 9.5 to 5. The worst panel we found in the sites POR 36 and USA 38, both with RN = 3.

Figure 1.15: Type I. Cracking after 4 and 8 years of exposure.

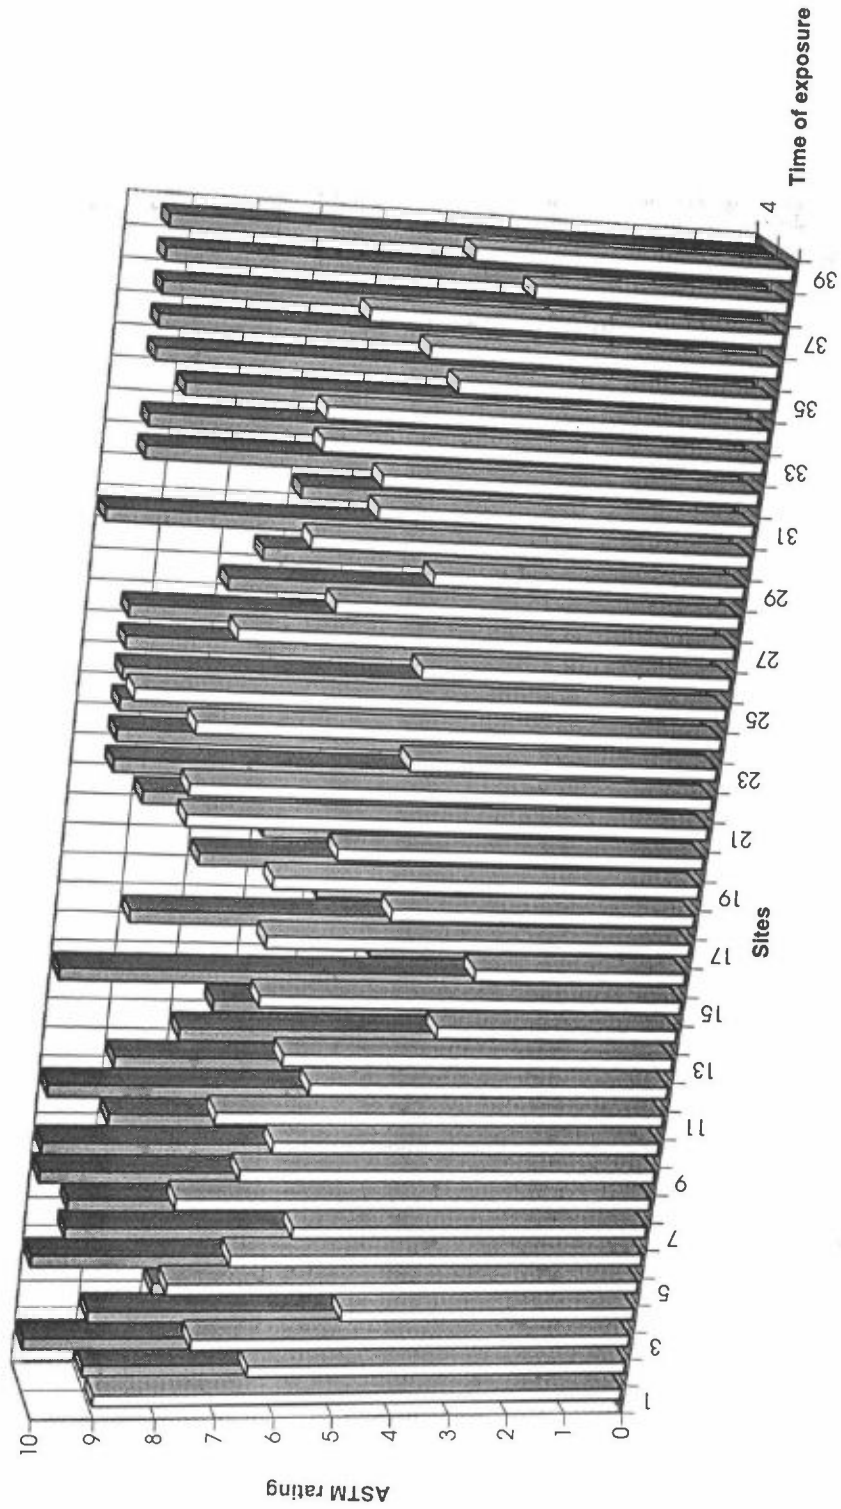
The best score we got at the sites SWE 25 (RN = 9.5) and CZE 1 (RN = 9). NOR 21 and NOR 22 and SWE 24 had RN = 8.5. The worst panel we found in ITA 16 (RN = 3.5), but also USA 38 and ITA 14 were bad (RN = 4). In this connection it should be mentioned that RN of the panel in USA 38 had dropped from 9.5 to 4 the last four years.

Figure 1.16: Type K. Cracking after 4 and 8 years of exposure.
