NILU OR : 6/92
REFERENCE : O-90096
DATE : JANUARY 1992
ISBN : 82-425-0334-6

External Building Materials in a Norwegian Town, Sarpsborg - Quantities and Degradation

J.F. Henriksen and A. Bartonova

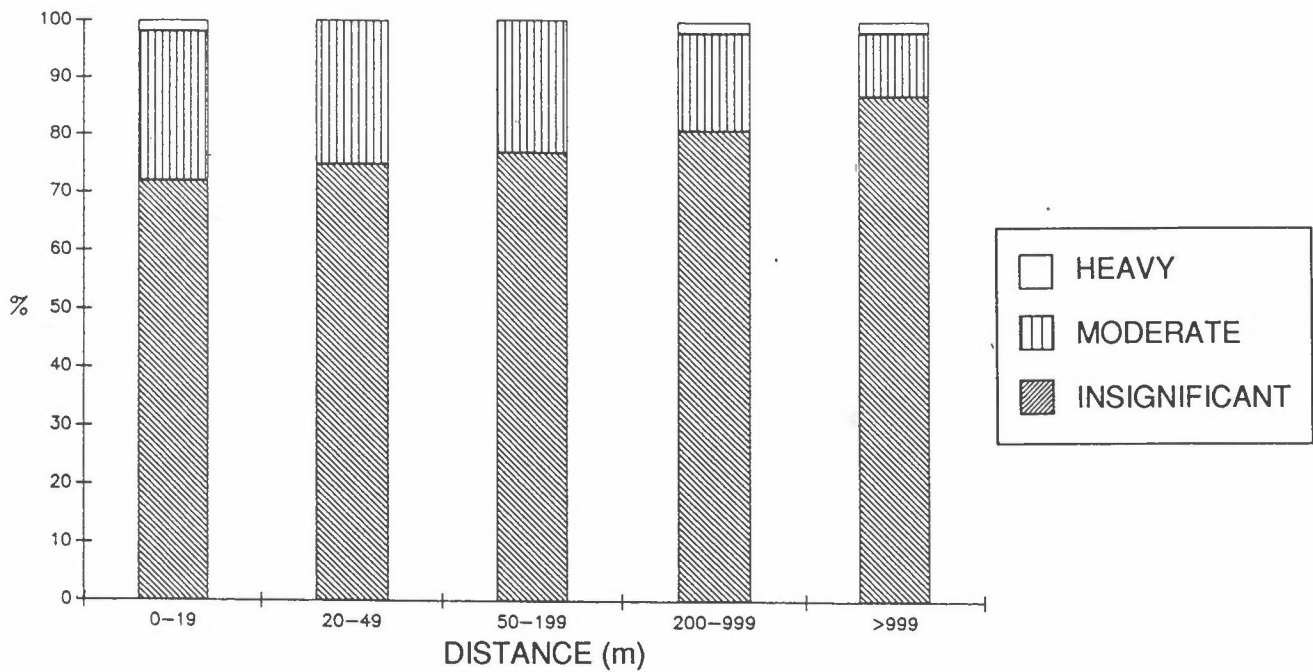
Figure 3 and 4 illustrate how the fouling varies with distance from roads with heavy traffic and distance from local pollution of SO₂. Both figures show that fouling is linked both to traffic and to SO₂ pollution. The percentage of facades with heavy fouling is small. One reason is that the maintenance periods for facades in Sarpsborg is short and very few facades will reach the class "heavy fouling" before they will be repainted.

Figure 3: Fouling of facades at different distance from roads with heavy traffic.

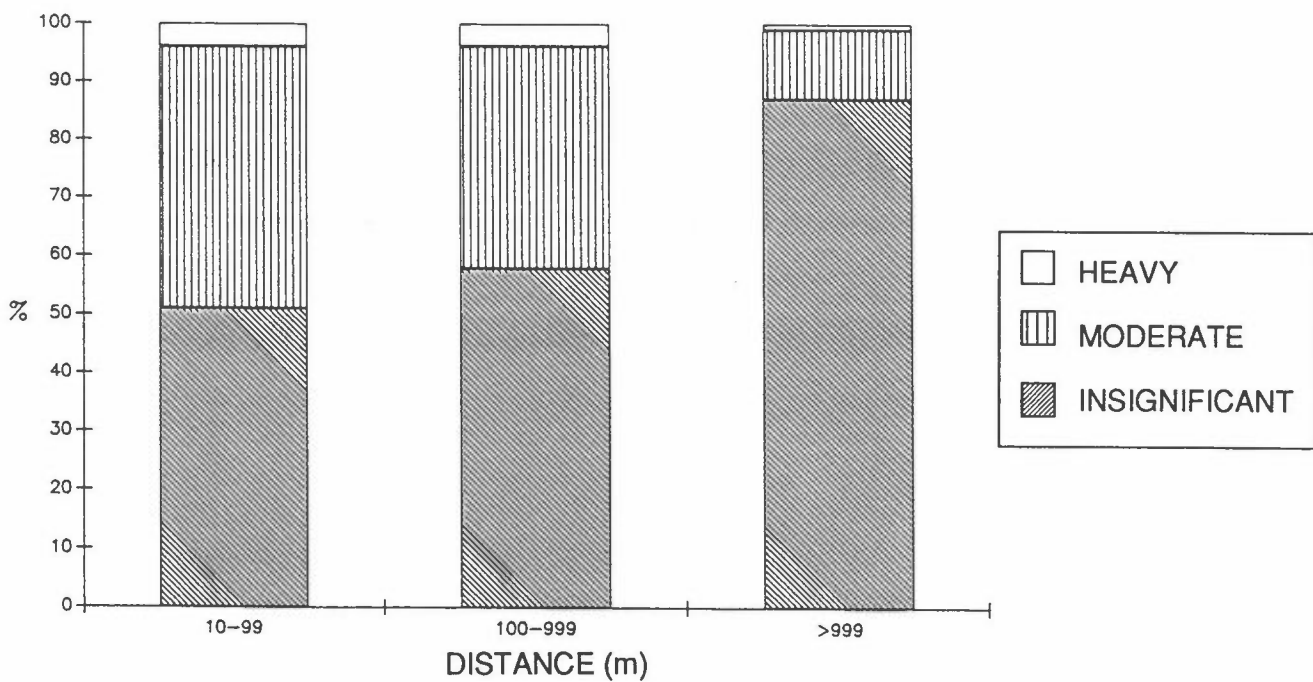
Figure 4: Fouling of facades at different distance from local SO₂-pollution.
