Article

# Recent Trends in Maintenance Costs for Façades Due to Air Pollution in the Oslo Quadrature, Norway

**Abstract:** This study assesses changes since 1980 in the maintenance cost of the façades of the historical 17th to 19th century buildings of the Oslo Quadrature, Norway, due to atmospheric chemical wear, including the influence of air pollution. Bottom up estimations by exposure–response functions for an SO<sub>2</sub> dominated situation reported in the literature for 1979 and 1995 were compared with calculations for the present (2002–2014) multi-pollutant situation. The present maintenance cost, relative to the total façade area, due to atmospheric wear and soiling was found to be about 1.6 Euro/m<sup>2</sup> per year. The exposure to local air pollution, mainly particulate matter and NO<sub>x</sub> gases, contributed to 0.6 Euro/m<sup>2</sup> (38%), of which the cost due to wear of renderings was about 0.4 Euro/m<sup>2</sup> (22%), that due to the cleaning of glass was 0.2 Euro/m<sup>2</sup> (11%), and that due to wear of other façade materials was 0.07 Euro/m<sup>2</sup> (5%). The maintenance cost due to the atmospheric wear was found to be about 3.5%, and that due

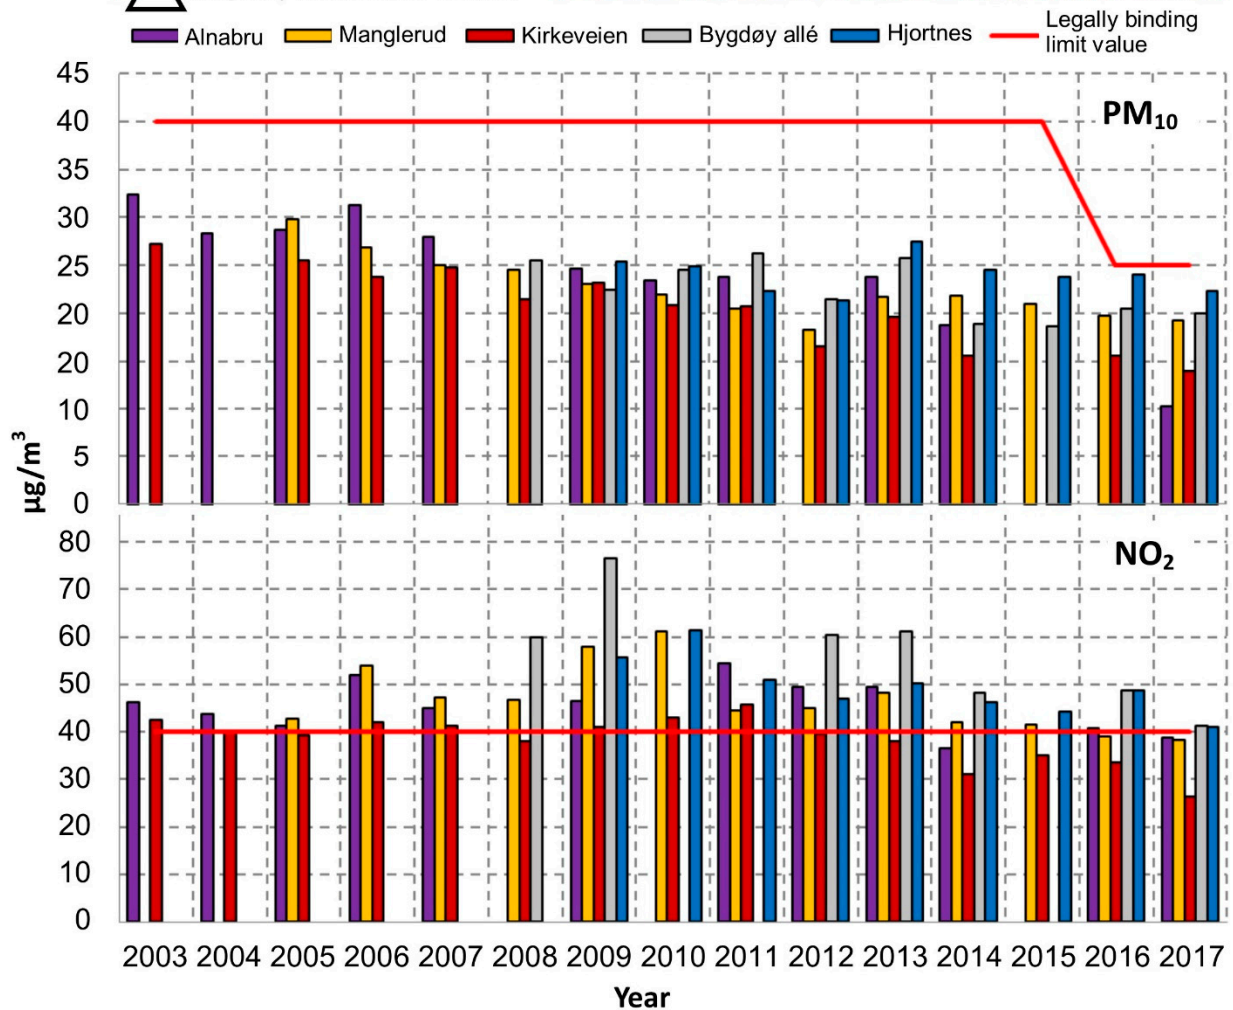
**Figure 1.** Annual average concentrations of PM<sub>10</sub> and NO<sub>2</sub> measured at air quality stations in Oslo, and legally binding limits, for the years 2003 to 2017. The values of PM<sub>10</sub> and NO<sub>2</sub> measured at each station are represented by bars with the same color as the triangles representing the geographical position of the stations on the map.

on the introduction of new stations in the years from 2008 to 2010. It should be noted that the concentrations of PM<sub>10</sub> and NO<sub>2</sub> were probably somewhat higher in 1995 than in 2003, as can be seen for the station “Kirkeveien” in [30], and thus that some of the atmospheric wear on the façades in Oslo in 1995 should have been explained by the exposure to these pollutants.

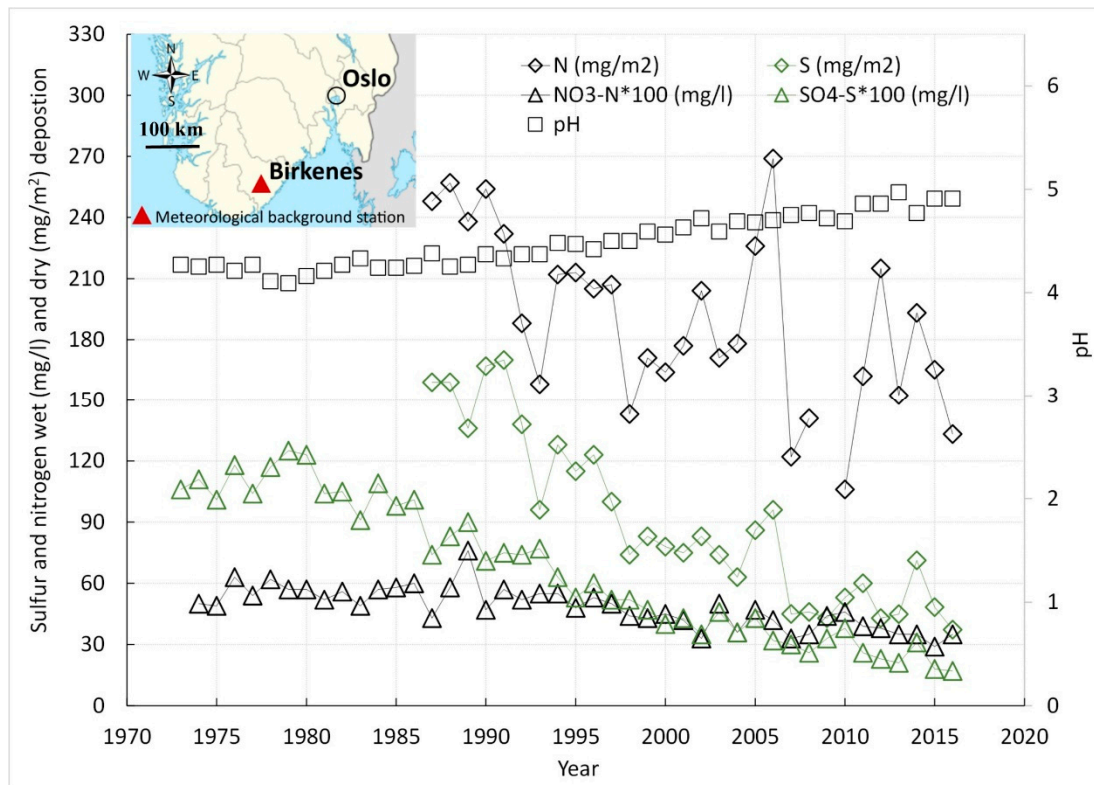
**Figure 2.** Trends of major air pollutants and acidity in precipitation measured on the Norwegian EMEP (European Monitoring and Evaluation Programme) background station Birkenes in southern Norway. Annual volume weighted mean concentrations of wet (mg/L), and dry (mg/m<sup>2</sup>), deposited sulfur and nitrogen.

Figure 2 shows pollution values measured since 1973 on the Norwegian EMEP (European Monitoring and Evaluation Programme) rural background station Birkenes in southern Norway [31].

Figure 2 shows a decreasing contribution from the long range transported and rural background pollution to the local air pollution in Oslo. The figures indicate a reduction in the contribution of the background pollution to the average atmospheric wear of façades in Oslo, and that calculations of the wear over the years from 2003 to 2014 could represent the present situation, in 2019, with a possible slight overestimation.

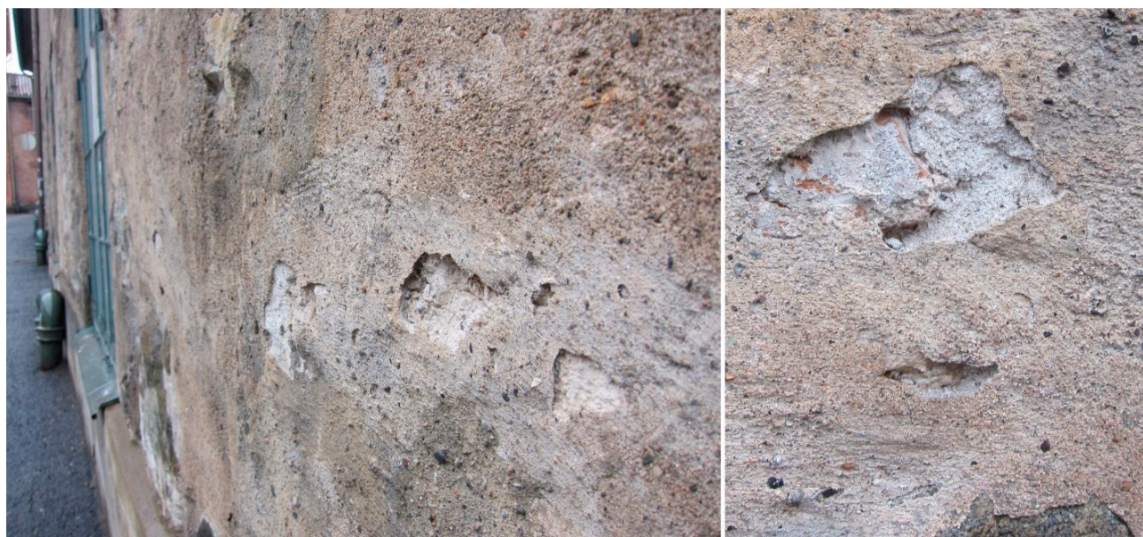
**Figure 3.** Initial and probably accelerating deterioration of a rough sand-containing rendering applied on the uneven surface of the building seen in Figure 4d, with protruding parts of stones from the wall under the rendering.

The exposure of a lime-containing rendering or mortar surface to the air and its wetting will result in some amount of more or less uniform chemical dissolution, leaching, and weakening. The calcium carbonate ( $\text{CaCO}_3$ ) in the renderings and mortars is, as for limestone, susceptible to accelerated dissolution in a polluted and acidic environment. Physical expansion and contraction cycles due to wetting and drying, frost and thaw, pore crystallization and dissolution of salts, and temperature fluctuations contribute to the weakening and damage. Finally, the rendering or mortar cannot any longer hold together or stick to a substrate or other surface, and micro-cracks or crevices appear. This is a critical point in the deterioration. The cracking often happens at some non-uniformity in the surface. This can be due to, for example, variations in application thickness, geometric features, such as corners and angles, or solid inclusions, which are more important for mortars. Many different biological organisms, such as bacteria, fungi, lichens, mosses, and larger plants, can grow on and affect the deterioration process. Bio-growth can protect surfaces, but often contributes to their weakening and subsequent accelerated damage [34]. The breaking of the protective shell of a rendering or of the bonding of a mortar allows more access of the atmospheric influences to weaker points in the structure, with consequently more rapid leaching, weakening, and accelerated deterioration (Figure 3).

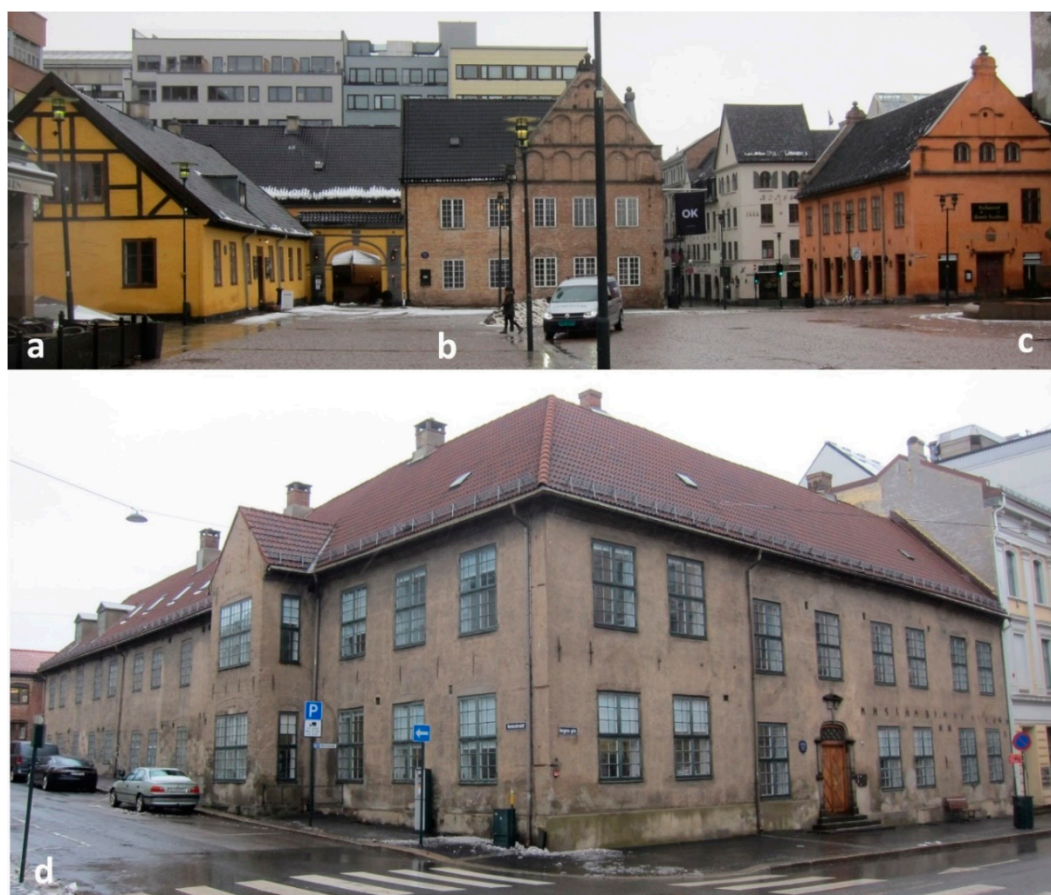
**Figure 4.** Buildings from 17th century Oslo. Top: from Christiania square, the main square in Oslo after 1624, (a) the oldest half-timbered house in Oslo, from the 1640s, (b) the oldest house in Oslo, from 1626, built by the council chief, (c) the first council house, built in 1641, and (d) the Christiania upbringing-house for poor children (1778–1917), built in 1640. Façade Materials: walls with painted lime rendering (a,c), brick (b), and rough unpainted sand-containing rendering (d); chimneys with unpainted rendering and brick (d); stained wood beams in walls (a) and painted wooden window frames and doors; glazed and unglazed (d) roof tiles; galvanized and painted metal elements.

Figure 4 shows façades of historic buildings on and close to the main square of the Oslo Quadrature.

The painted renderings dominate the façades. Galvanized (zinc covered) steel surfaces and copper roofing are the main metallic surfaces. The estimated atmospheric wear and cleaning cost for the façades were described by the maintenance situations for the façades, as defined by the façade materials, the damage process (weathering/corrosion or soiling), the estimation year(s), the maintenance practices and costs, and the values for the environmental parameters needed to do the calculations by the ERFs, as given in Tables 1 and 2. The tables are included here as summary references to the input parameters and values, which can be consulted as needed through the reading.

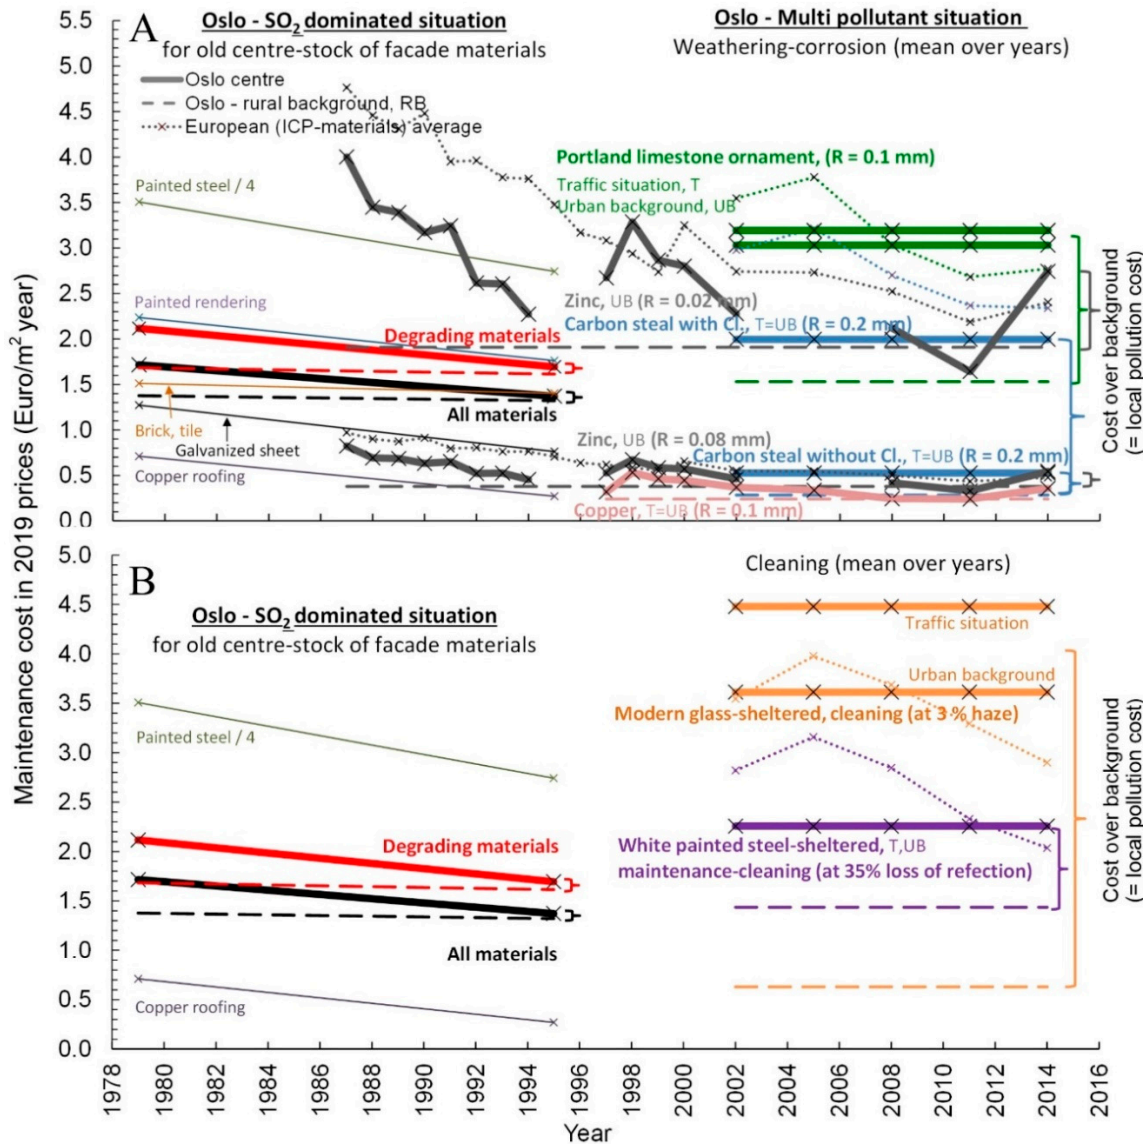
**Figure 5.** Building maintenance and cleaning costs in center Oslo since 1979, due to atmospheric wear, including the influence of air pollution, calculated by available exposure–response functions (ERFs) for a selection of materials. Comparison between reported values for the SO<sub>2</sub> dominated situation in 1979 and 1995 (both in **A** and **B**) and estimated values for the multi-pollutant situation for maintenance due to weathering-corrosion (**A**) and soiling (**B**). Every displayed point (on the curves) is the calculated cost for one material in one year in one of the pollution situations given by the legend and colored text. Each legend entry in grey thus represents all the similarly outlined curves of different color. The curves represent the materials noted by the accompanying text in the same color. It should be noted that an assessment of, and adjustment to, most realistic values for the respective maintenance cost in the Oslo quadrature is made in the Discussion, Section 6.

Figure 5 shows the results for the estimation of the maintenance and cleaning costs of the building façades in the Oslo Quadrature in the years from 1979 to 2014 due to atmospheric wear, including the influence of air pollution. The figure includes a complete comparison of the calculated costs by the ERFs for the noted, and differently colored (in text and outline), materials and pollution situations over the evaluation years. The initial impression of the figure may be somewhat confusing, but every displayed point (on the curves) is simply the calculated maintenance cost for one material in one year in one of the pollution situations given by the legend and colored text. Thus, each legend entry in grey represents all the similarly outlined curves of different color. The main purpose of the figure is to compare the values for the SO<sub>2</sub> dominated situation in 1979 and 1995 and for zinc since 1987 with those estimated for Portland limestone, carbon steel, copper, and for the cleaning of white painted surfaces and glass, for the multi-pollutant situation, from 2002 to 2014. For Portland limestone, carbon steel, and the cleaning there were no observable trends in the results in the multi-pollutant situation, but significant variation between the years. For the sake of presentation and comparison, it was therefore decided to show the average periodic costs (straight horizontal lines) from 2002 to 2014 for each of these materials.

The upper part of Figure 5A compares the values in 1979 and 1995 with maintenance due to weathering-corrosion. The lower part of Figure 5B compares the same values in 1979 and 1995 with cleaning costs due to soiling and haze. By the legend and colored text, Figure 5 gives the main conditions for the estimations related to the pollution situations (traffic, urban, and rural background situations) and the maintenance tolerances ( $R$ ) applied in the estimations for the many materials. The display of all the results in the two connected diagrams, Figure 5A,B gives a quick impression of how the values for the maintenance cost estimates for the “present” (2002–2014) period compare to the recent past (1979–1995). As the single materials were not directly comparable, except for galvanized sheet and zinc, this seemed to be the best way to give an overall comparative view of the estimated maintenance costs and trends. The crosses on the curves show the measurement/estimation years. For simplicity, Figure 5B only shows the lowest and highest maintenance costs calculated for individual materials in 1979 and 1995. The “European average” costs for copper were similar to the values in the center of Oslo and are not shown.

The main result seen in Figure 5A is that the present (2002–2014) estimated maintenance costs due to atmospheric wear are in the same overall range as from 1979 to 1995. The estimated maintenance cost of painted steel in 1995 due to atmospheric wear, shown in Figure 5, was about four times higher than for any other material. As an ERF for the multi-pollutant situation did not exist for painted steel, no calculation was made for this material for the 2002–2014 period. Considering, however, the relative similarity of the cost estimates for other materials since 1979, the situation, with much higher cost for the maintenance of the painted steel, would probably be similar for the years after 1995. The maintenance cost due to air pollution after 2002 for metallic surfaces (zinc, copper, and carbon steel, without including a chloride effect) remains low with an impact of the local air

Figure 5B shows that the cleaning cost, especially for glass/windows, may today generally be higher than the corrosion costs (Figure 5A, see also Discussion). Except for the much higher values calculated for the carbon steel corrosion for the European ICP-materials averages, the cost values for these averages were about similar to the values for Oslo, as is also shown by comparison to values reported in [25]. The reason for the lower steel corrosion in Oslo is the sensitivity of carbon steel to SO<sub>2</sub> and the lower measured SO<sub>2</sub> concentration in Oslo (Table 1, [38,39]). Contrary to the large variation between years in the cost values for the single station in Oslo, the European ICP-materials averages indicate a trend towards lower maintenance costs due to atmospheric wear of façades over the period 2002 to 2014.

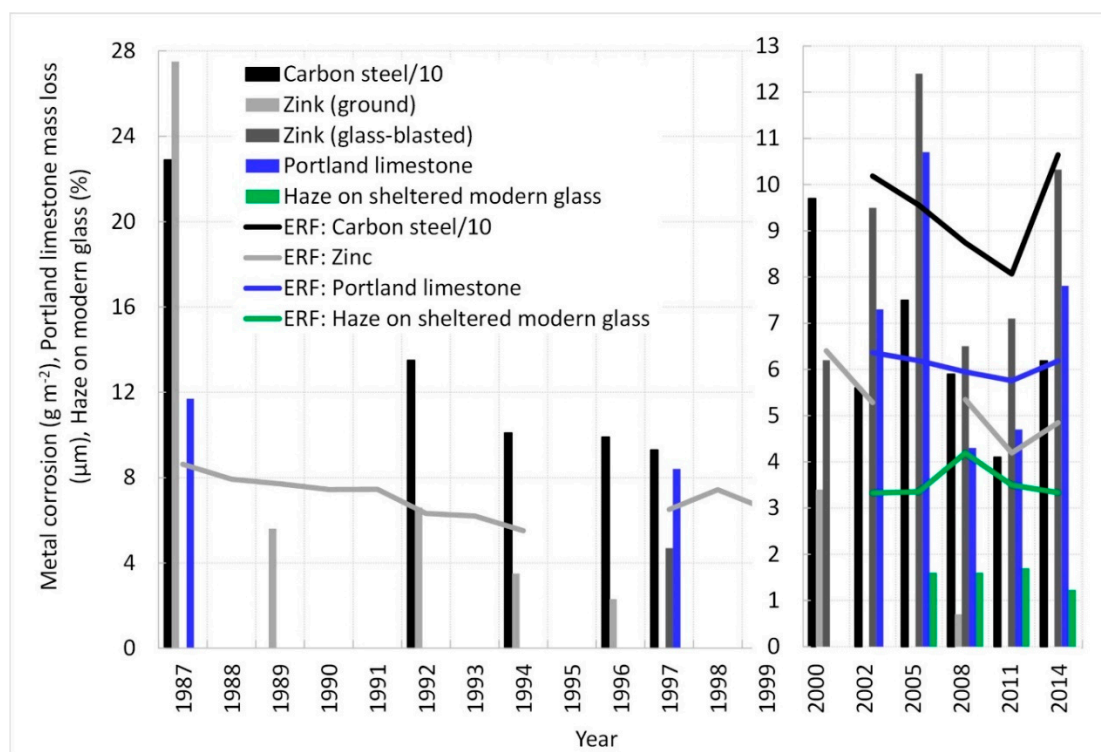
**Figure 6.** Response results calculated by ERFs (Appendix A) from environmental values and measured after one year of exposure of experimental samples at the ICP-materials station in Oslo.

The results for the multi-pollutant ERFs are only shown from 2002, as PM<sub>10</sub> values for Oslo were only available from that year, based on correlation with particle deposition [22]. The same ERF for zinc in an SO<sub>2</sub> dominated situation was used for all the years. As the ERFs were developed by statistical methods from measured environmental and corrosion data, some differences between the calculated and the measured values for the wear at single stations is expected. This difference is an indication of how well the ERFs represent the observed situation at that station. Figure 6 shows that for Oslo there was no systematic error in the wear calculated by the ERF for Portland limestone, but significant uncertainty in the prediction for single years. The zinc function systematically underestimated the loss of glass-blasted zinc exposed from 2002 to 2014, but not in the years 1997 and 2000, and overestimated that of ground samples, except in 1987 and 1992. The carbon steel and haze functions overestimated the responses measured on these materials.

The zinc function was developed for ground zinc in the SO<sub>2</sub> dominated situation. Glass-blasted zinc has a somewhat rougher surface and higher corrosion rate, as can be seen for the years 2000 and 2008, when the corrosion of these different surface finishes was compared experimentally [36]. The larger presence of different pollutants relative to SO<sub>2</sub> after 2000 may be another reason for the underestimation of the corrosion of glass-blasted zinc from 2002. A new multi-pollutant function was developed for zinc [20], but more recent correlations within ICP-materials [44] indicate that this inclusion of additional pollutant terms is uncertain.

The overestimation for carbon steel could be due to longer periods of cold and dry weather in Oslo giving less corrosion than the European average, and/or differences in the composition of PM<sub>10</sub> in Oslo as compared to other ICP-materials locations. Oslo has several winter months during the year with temperatures below freezing and snow. This may reduce the corrosion of metals as compared to the European average, but could possibly increase the physical erosion of stones and other materials, related to frost, thaw, and humidity cycles. PM<sub>10</sub> consists of a range of possible particle sizes and compositions, which will vary between locations, and which could have different corrosion effects. Oslo has substantial emissions of fine particles from residential wood burning on cold winter days and of re-suspended road dust on days with dry and cold weather in the winter and spring. This emission often happens together with temperature inversions, which traps the pollutants in stable air over the city and gives the highest concentrations of PM<sub>10</sub> though the year. It may be that the exposure to this PM<sub>10</sub> in Oslo is relatively less corrosive and soiling than the average European PM<sub>10</sub> exposure.
