Supplement of

Calibration and assessment of electrochemical low-cost sensors in remote alpine harsh environments

Federico Dallo et al.

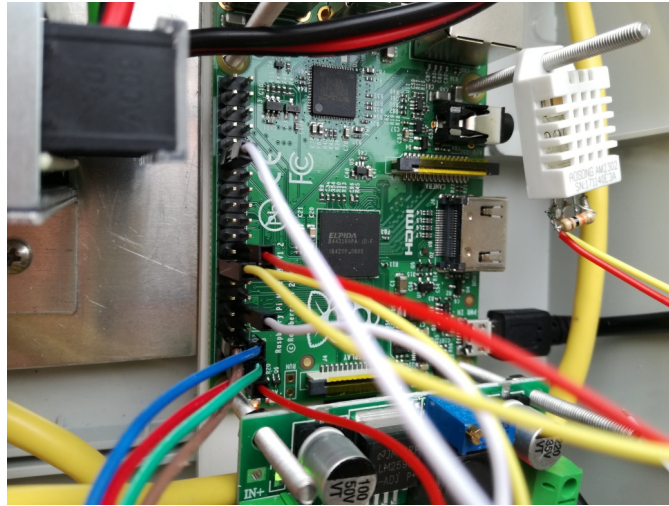
Figure S1.1. The Raspberry Pi with the GPIO on the left. The schematic of the pins are shown in Figure S1.4.

The most tricky operation in case of maintenance could be the correct wiring of the acquisition board and the T&RH sensors to the Raspberry Pi. In Figure S1.1, Figure S1.2 and Figure S1.3 are shown the wires that goes to the Raspberry Pi, while
 45 Figure S1.4 shows the pins scheme of the Raspberry Pi. Here is the list of connection from acquisition board to Raspberry Pi:

Figure S1.4. This is the scheme of the Raspberry Pi GPIO pins. Check if you're looking with the right orientation (in Figure S1.1 the pin 1 is on the bottom-right). This "table showing all 26 pins on the P1 header, including any special function they may have," was made by SparkFun and can be reused under the CC BY licence.

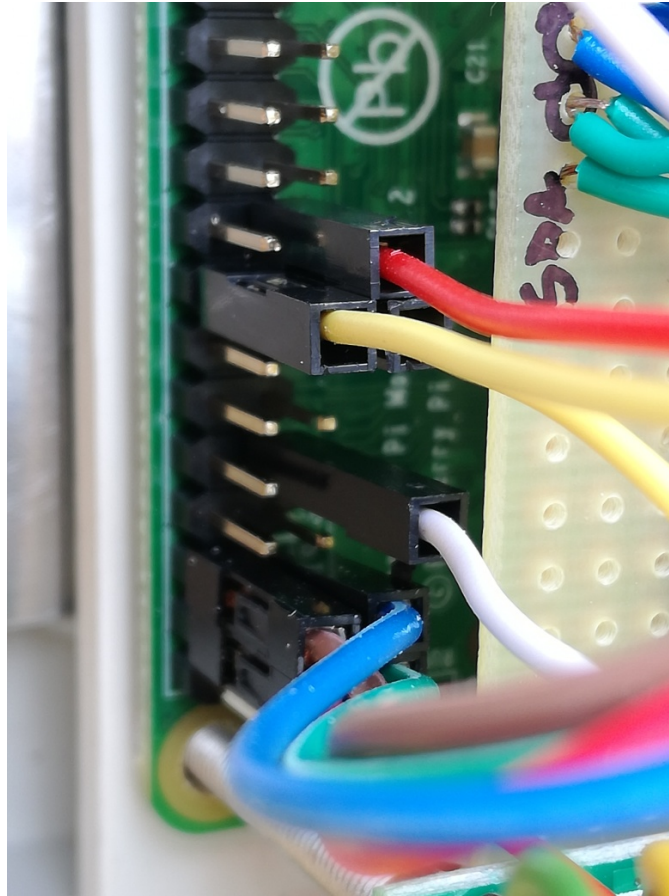
Figure S1.2. A detail of the wiring between the acquisition board and T&RH sensors to the GPIO of the Raspberry Pi. Here are shown the GPIO pins from 1 (bottom-right) to 24 (top-left).

- RED on 5 V, pin04
- BROWN on GND, pin06
- GREEN on SDA, pin03
- BLUE on SCL, pin05

50 Here is the list of connection from T&RH on the top of sensor 1 (it has a 1 on it) to Raspberry Pi:

- RED on 3.3 V, pin01
- WHITE on GND, pin09
- YELLOW on GPIO22, pin15

Here is the list of connection from T&RH on the top of the acquisition board (it has a 4 on it) to Raspberry Pi:

- 55
- RED on 3.3 V, pin17
 - WHITE on GND, pin30
 - YELLOW on GPIO23, pin16

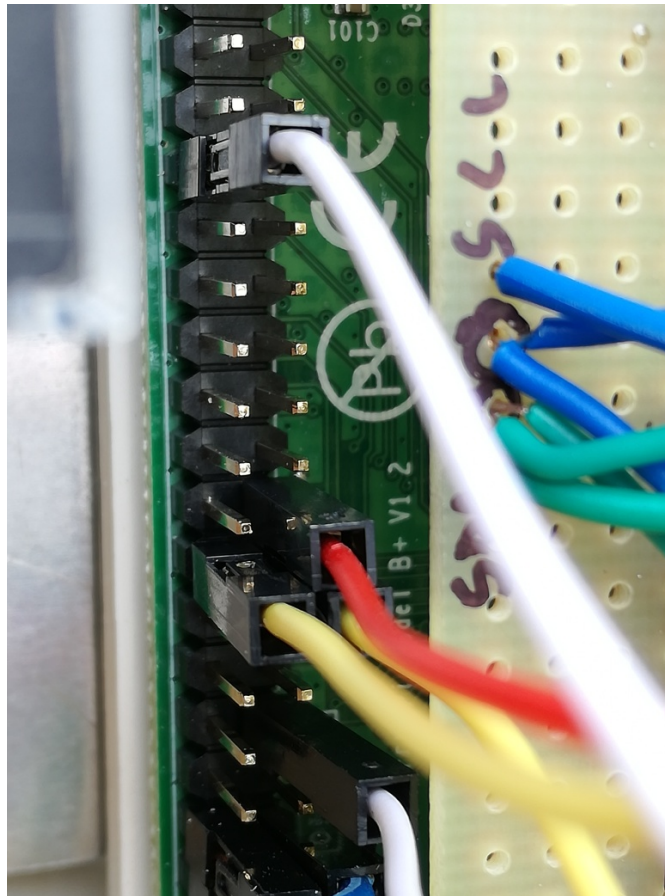
Figure S1.3. A detail of the wiring between the acquisition board and T&RH sensors to the GPIO of the Raspberry Pi. Here are shown the GPIO pins from 9 (GND with white wire on bootom-right of the pic) to 30 (GND with white wire on top-left of the pic).

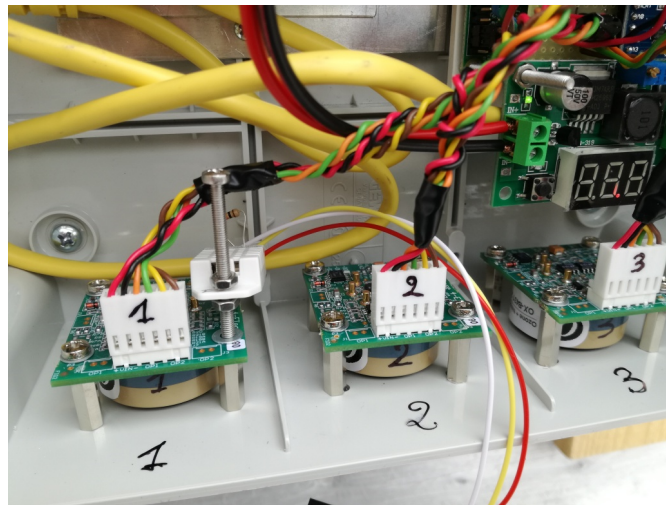
Figure S1.5. These are the three working sensors, and the T and RH sensor close to Sensor 1.

Each sensor is fastened with eight Phillips screws, four from the inside and four from the outside. In Figure S1.5 you can see that each sensor is provided of four spacers and stainless steel flat washers. From the outside there are four rubber gaskets to protect from humidity that may come into the box.

As shown in Figure S1.5, sensors are wired using a numbered plug. In case of need to change the sensor the procedure should be straightforward; unplug the sensor, unscrew it using the Phillips screwdriver and the wrench, replace it with the new sensor and plug it.

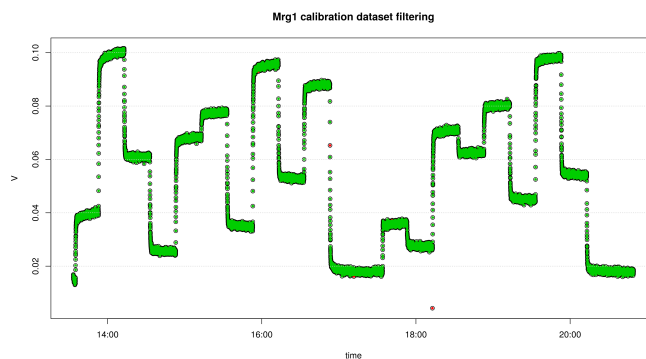
Figure S2.1. Example of the automatic filter to detect outliers in the dataset collected during laboratory calibration.

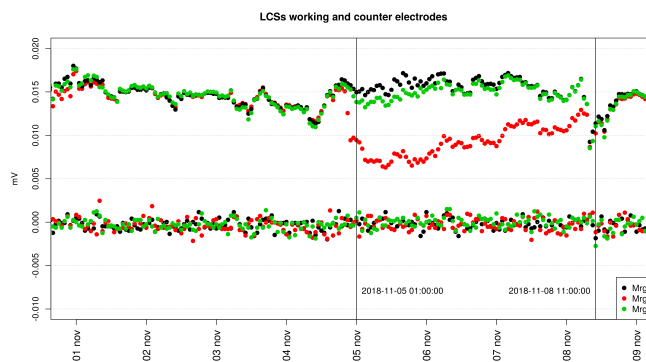
Figure S2.3. The behaviour of the Mrg2 sensor was not consistent in respect to the others LCSs from 1AM November 5 to 11PM November 8. We were not able to identify the cause of this temporary malfunction, but it represents an interesting event proving the importance of considering low-cost sensors redundancy. The data from Mrg2 flagged as erroneous readings were excluded from the dataset and statistical analysis

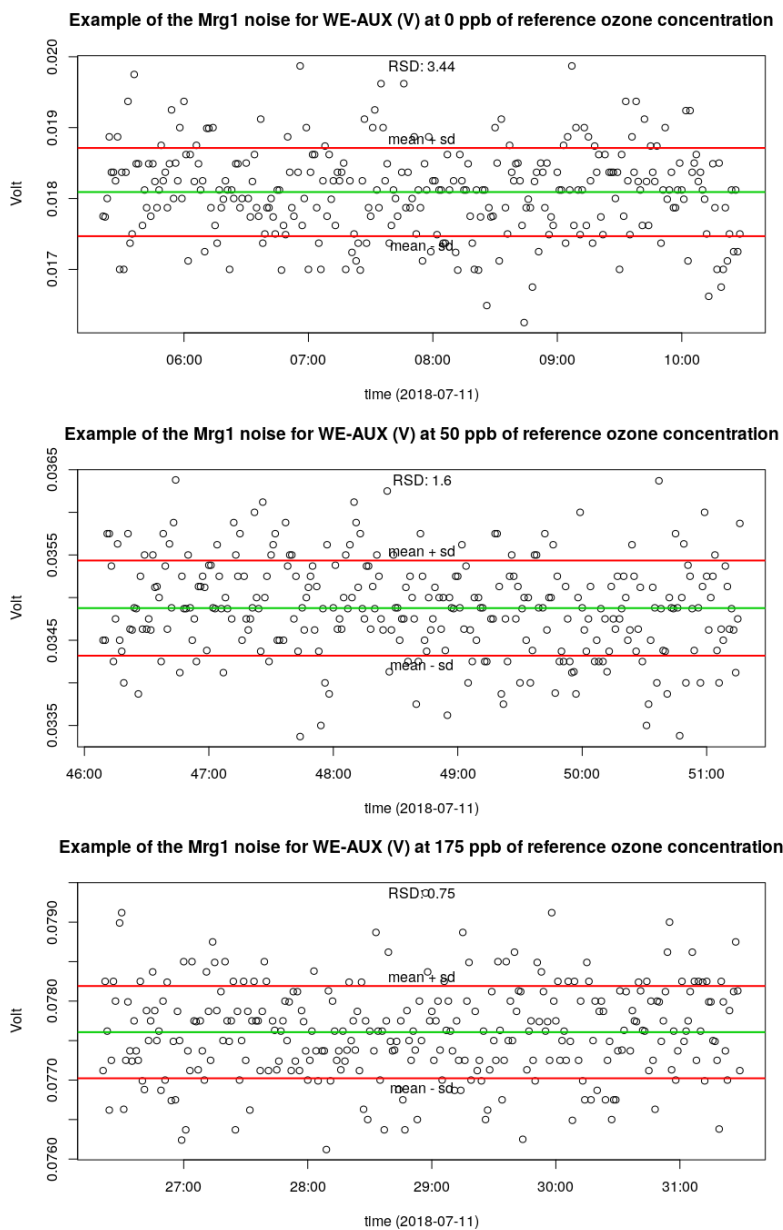
Figure S3.1. Electrical noise of the LCSs.

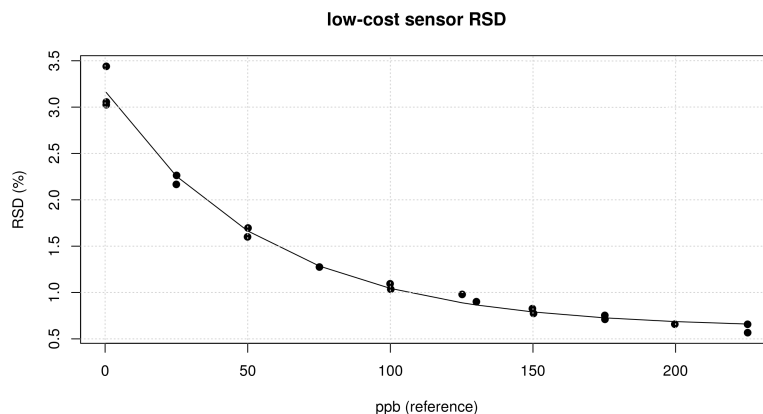
Figure S4.1. The RSD for the LCSs is lower for higher ozone concentration.

The mean voltage response of Mrg2 was 0.8 ± 0.7 mV, when reference ozone concentration was 0.4 ± 0.1 ppb, and reached 89.3 ± 0.9 mV when reference ozone concentration was 250.2 ± 0.3 ppb. Precision of the Mrg2 sensor was 3.5% for values close to the LOD and decreased to 0.9% for ozone concentrations higher than 200 ppb. Mrg2's MAE was 2.5 ppb, LOD was 5 ppb, LOQ was 17 ppb and LDR was 5-250 ppb ($R^2 = 0.999$).

115 The mean voltage response of Mrg3 was 38.3 ± 0.9 mV, when reference ozone concentration was 0.4 ± 0.1 ppb, and reached 123.5 ± 0.9 mV when reference ozone concentration was 249.7 ± 0.2 ppb. Precision of the Mrg3 sensor was 2.6% for values close to the LOD and decreased to 0.7% for ozone concentration higher than 200 ppb. MAE for Mrg3 was 2.6 ppb. Mrg3's LOD was 3 ppb, LOQ was 9 ppb and LDR was 3-250 ppb ($R^2 = 0.998$).

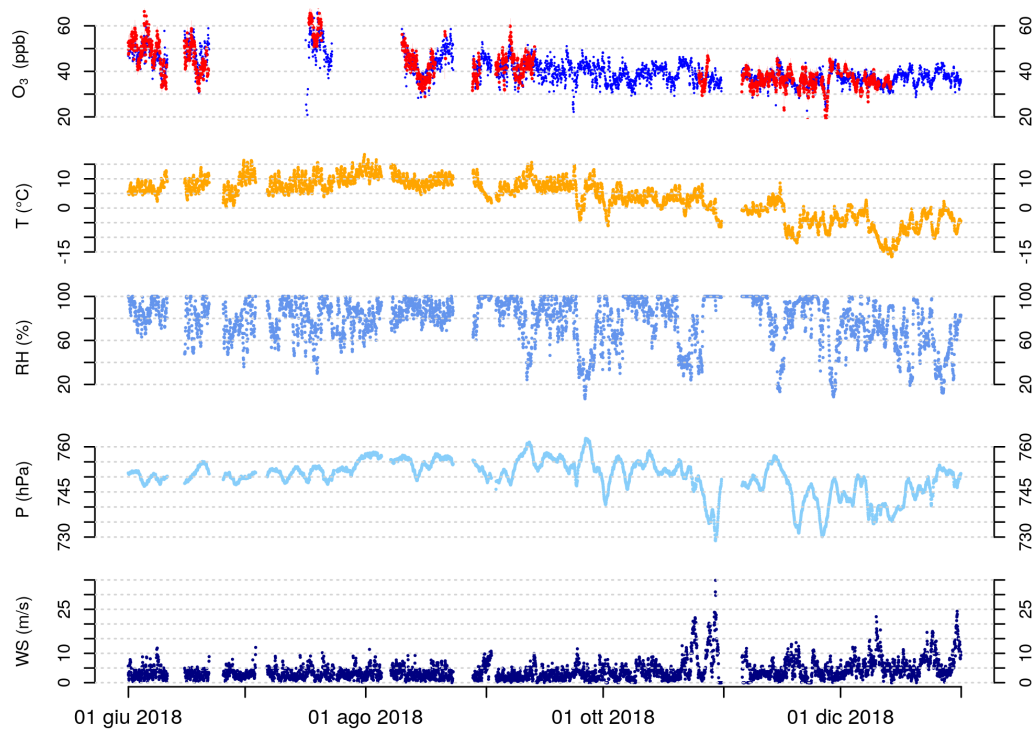
Figure S5.1. Time series of ozone concentration measurements and meteorological variables for the period June-December 2018. The first plot from the top show the LCSs ozone concentration (ppb) in blue and the reference ozone concentration (ppb) in red. The second plot shows the external air Temperature (T). The third plot shows the Relative Humidity (RH). The third plot shows the Atmospheric Pressure (P) and the fourth plot shows the Wind Speed (WS). It is clearly visible the Vaia storm event that hit the North-eastern Italy on 29th October.

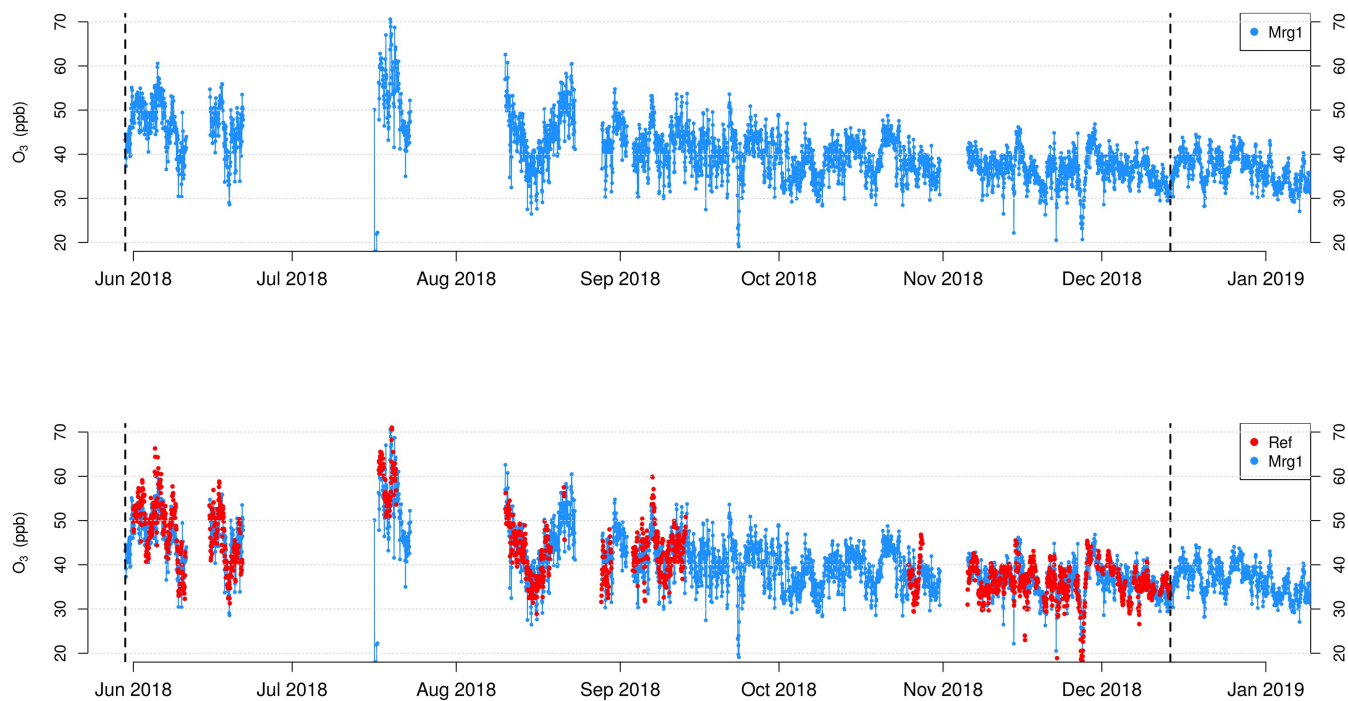
Figure S5.2. Time series of ozone concentration measurements and meteorological variables for the period June-December 2018. The first plot from the top show the Mrg1 ozone concentration (ppb) in blue and the reference ozone concentration (ppb) in red.

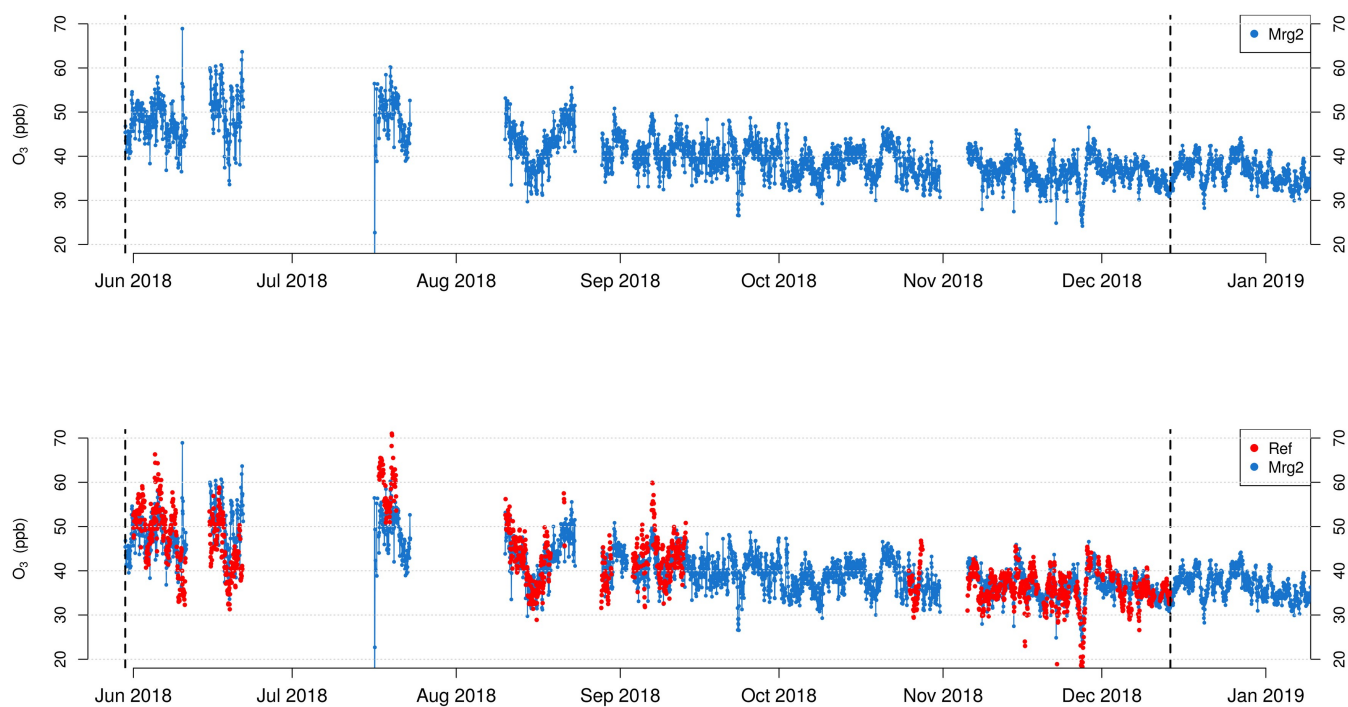
Figure S5.3. Time series of ozone concentration measurements and meteorological variables for the period June-December 2018. The first plot from the top show the Mrg2 ozone concentration (ppb) in blue and the reference ozone concentration (ppb) in red.

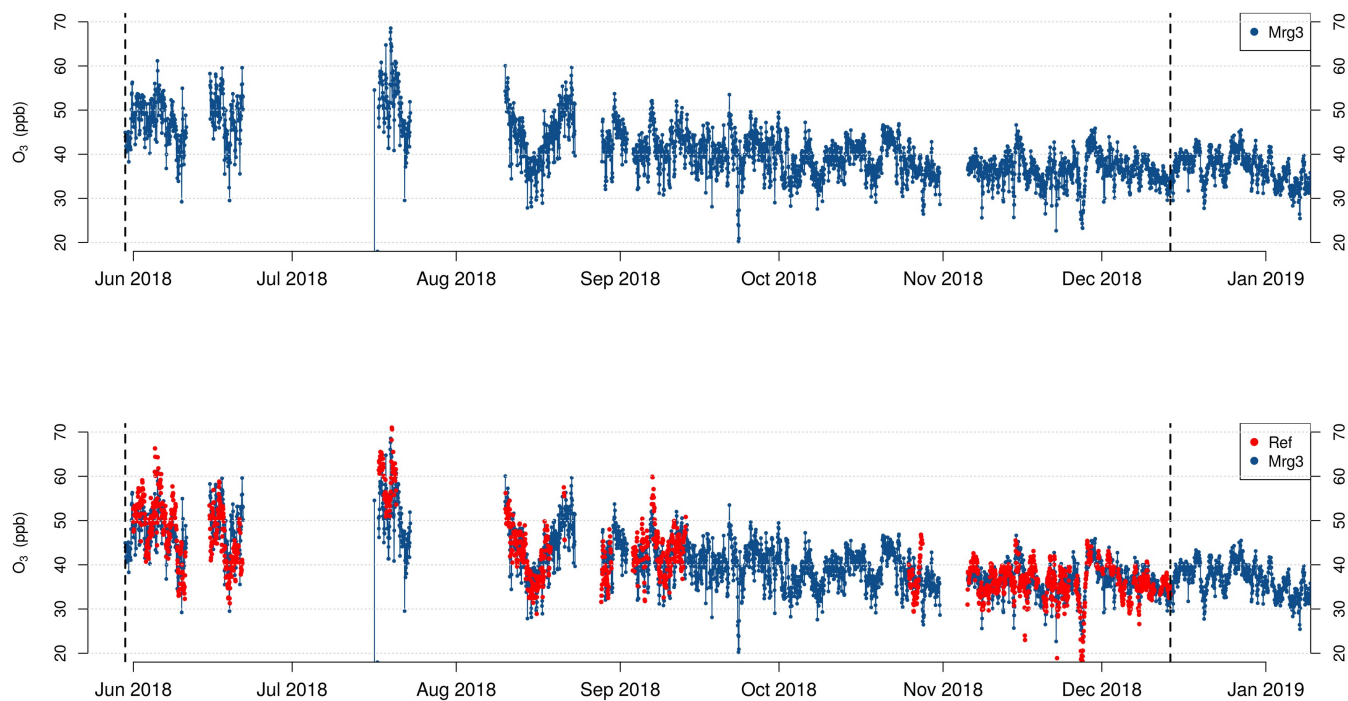
Figure S5.4. Time series of ozone concentration measurements and meteorological variables for the period June-December 2018. The first plot from the top show the Mrg3 ozone concentration (ppb) in blue and the reference ozone concentration (ppb) in red.

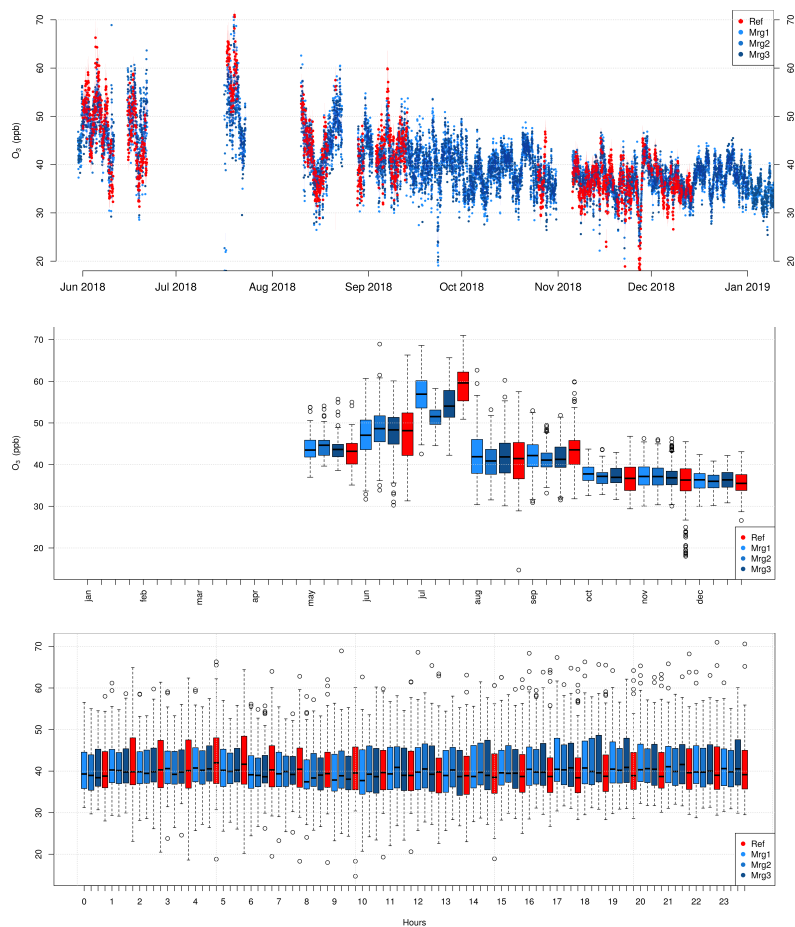
Figure S5.5. Time series of ozone concentration measurements and meteorological variables for the period June-December 2018. Monthly and hourly boxplots for the period June-December 2018. LCSs average values are reported in blue gradient and the reference ozone concentration is reported in red. Observations from periods where both the LCSs and the reference were operational have been considered for the monthly and hourly boxplots.

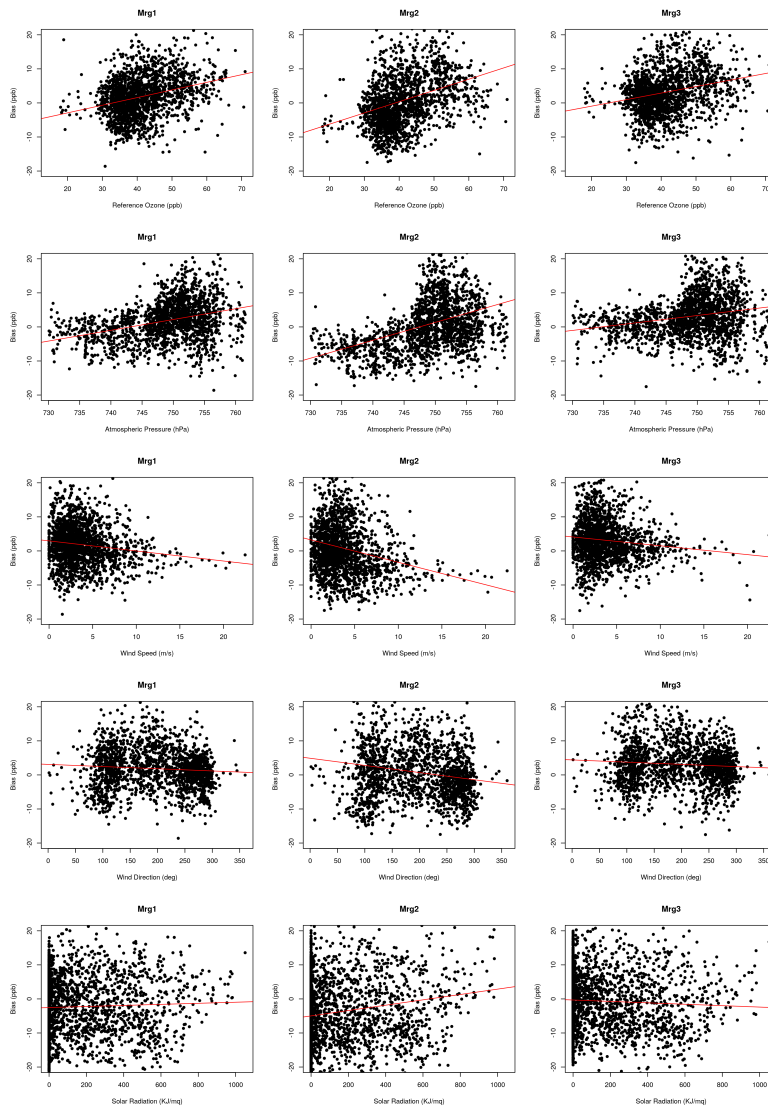
Figure S5.6. Non correlating variables. No evidence of correlation was found among the bias ($O_3^{lcs} - O_3^R$) and the incident solar radiation (PCC ≈ 0.05 , p-value ≈ 0.1), the atmospheric pressure (PCC ≈ 0.24 , p-value ≈ 0.3), the wind speed (PCC ≈ -0.22 , p-value ≈ 0.1) and the wind direction (PCC ≈ -0.10 , p-value ≈ 0.4).
