NILU : OR 39/2000
REFERENCE : O-8208
DATE : SEPTEMBER 2000
ISBN : 82-425-1202-7

**International Co-operative
Programme on Effects on Materials,
including Historic and Cultural
Monuments**

**Evaluation of decay of painted systems for steel
after 1 and 2 years of exposure (1997-1999)**

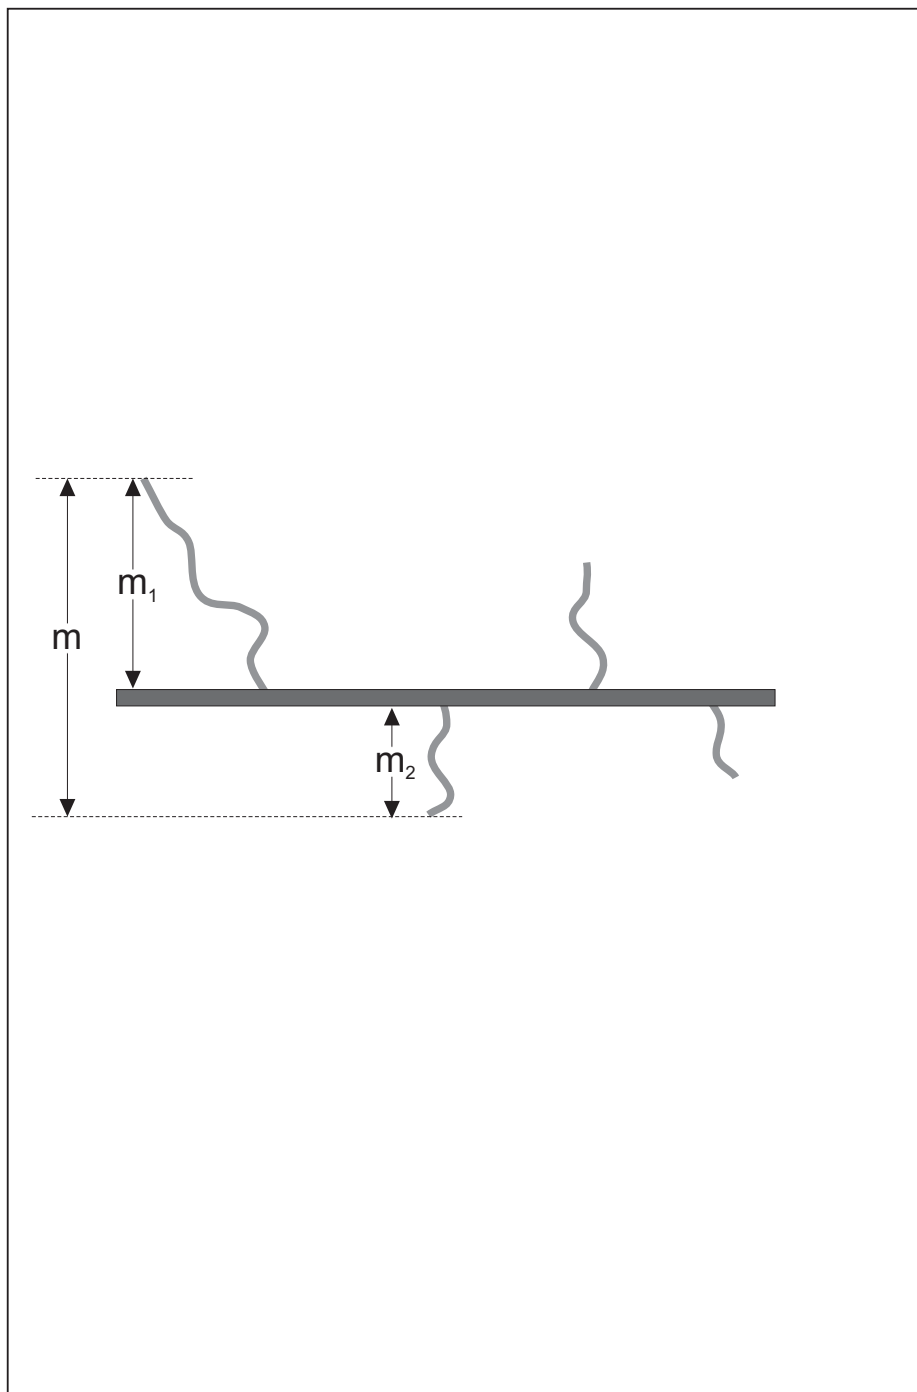
Evaluation techniques for filiform corrosion are described in ISO standard 4623. In our evaluation we divide the results into four groups. First group is panels without any sign of filiform corrosion marked “none” in Table 2. Second group is panels where beginning sign of threads is observed in microscope, marked “slight” in Table 2. Third group is panels with filiform corrosion on one side of the cut. The spread from the cut of the longest thread is measured in millimeter in the same way as the measurement of m_1 in Figure 1. The value is given in Table 2 and marked with the exponent 1. The fourth group is illustrated in Figure 2. The longest thread in both directions is measured, m_1 and m_2 . The mean value (M) given in Table 2 is marked with the exponent 2 and is calculated from the total spread of the longest thread in both directions (m) from the equation $M=(m-1)/2$ since the width of the cut, is 1 millimeter.

Figure 2: Illustration of evaluation of filiform corrosion on testpanel with cut.
